PANAGIA MELANDRINA CHURCH

Structural Assessment And
Design Of Emergency Repairs
And Supporting Measures

***BIENNIAL OF ARCHITECTURAL AND
URBAN RESTORATION,***

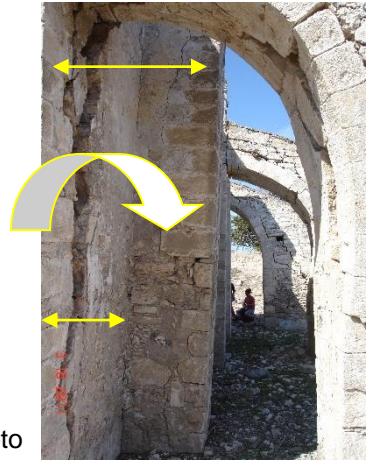
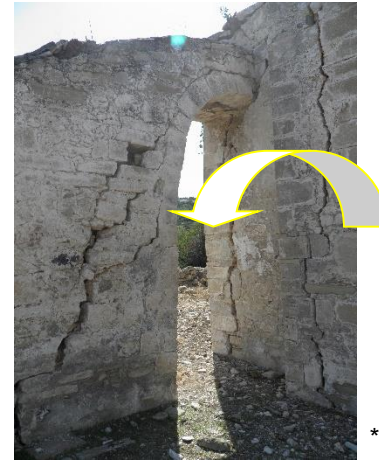
- Extensive severe cracks on the load bearing masonry of the Church – Large dislocations & torsional displacements on E side.

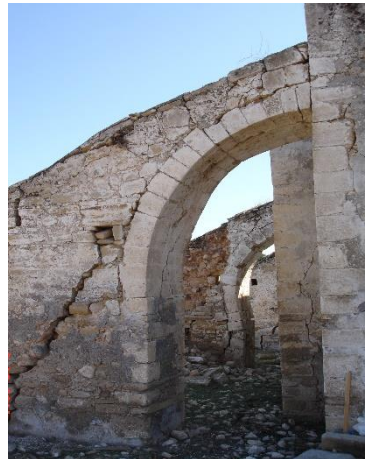
- Extensive severe cracks on all counterforts and partial collapse of one of them.

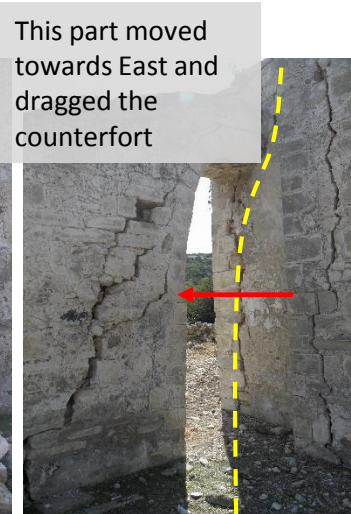
This part moved towards East and dragged the counterfort

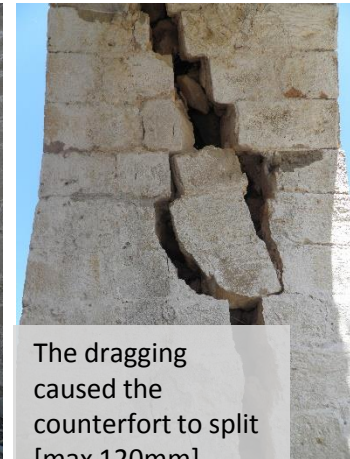
The dragging caused the counterfort to split [max 120mm].

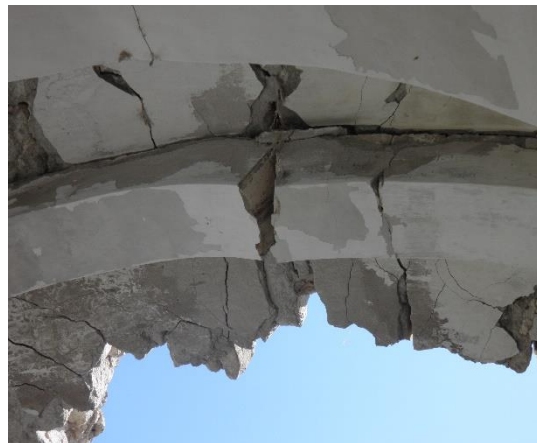
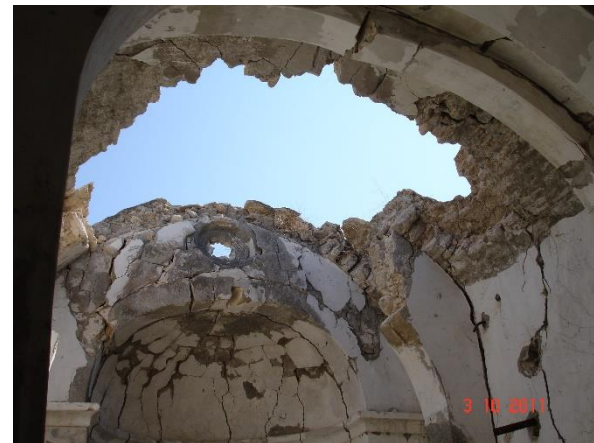
- Extensive damages on all arched masonry beams & total collapse of one of them.

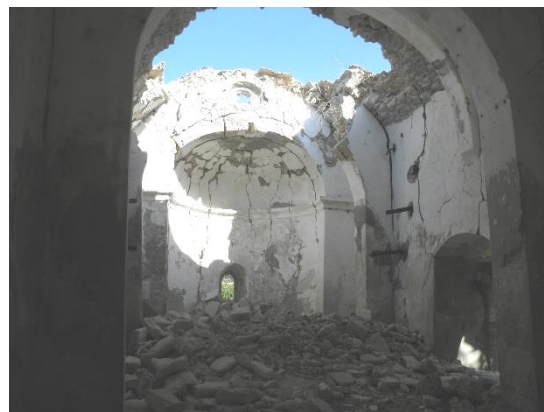
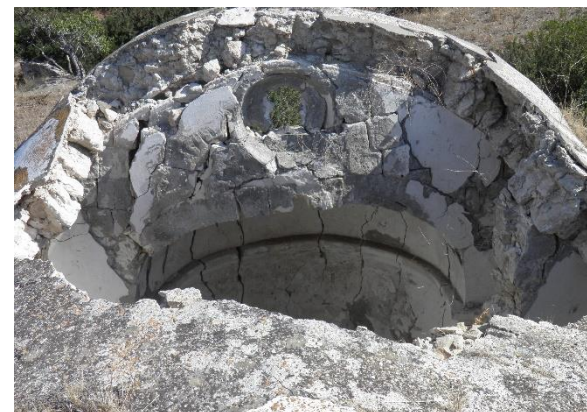
- Partial collapse of the roof & extensive cracking on the rest of it.

- **Covering & protection of the roof** – Curved Marine Plywood panels & heavy duty carbonate type are installed to cover & protect interior from rain, water, birds or other possible enemies causing further damage.

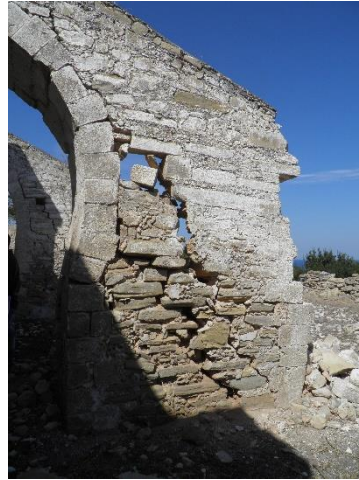
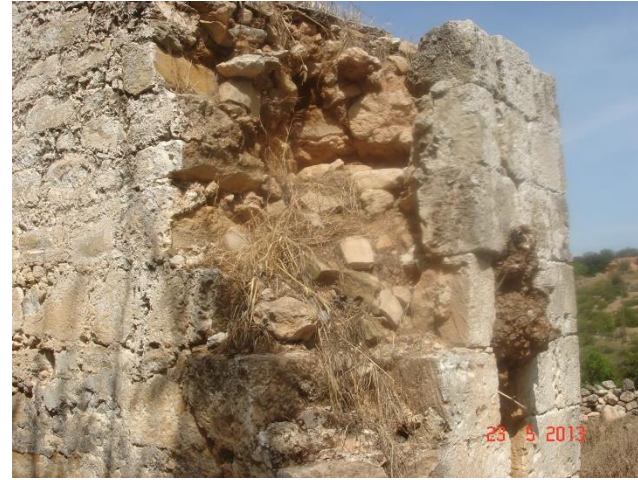
- Poor or no joining plaster, mortar & pointing in masonry walls.

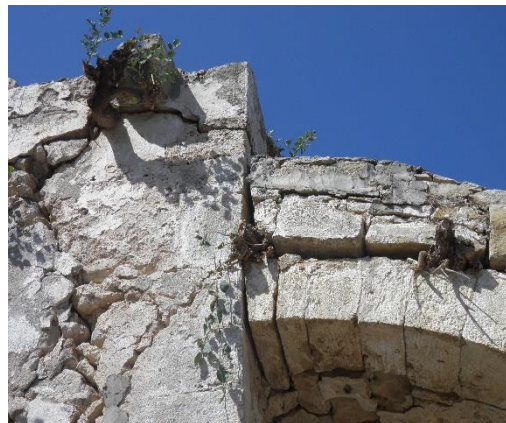
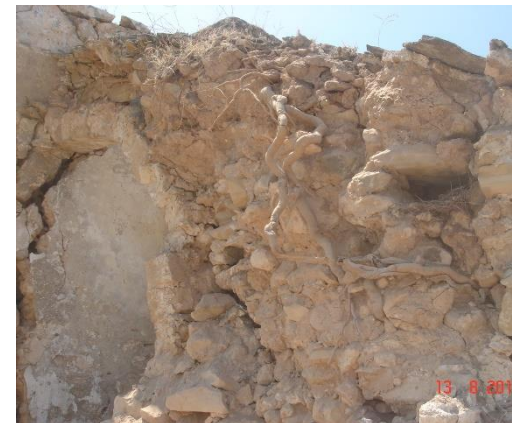
- Uncontrolled plantation / vegetation inside the body of the walls, roof and counterforts.

- **Removing plantation / vegetation with pesticide** - Growing plantation causes further damage in the body of the walls. Plantation should be removed before and after the completion of emergency measures

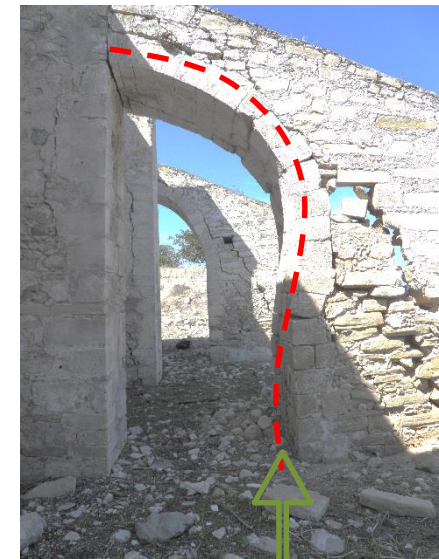
- Counterforts behavior:
 - Simply attached to the body of the Church – No participation in gravity loads.
 - All diagonal cracks are due to horizontal “pushing” coming from the main structure’s vertical deformation.

Actual Deformation /
Collapsing portion

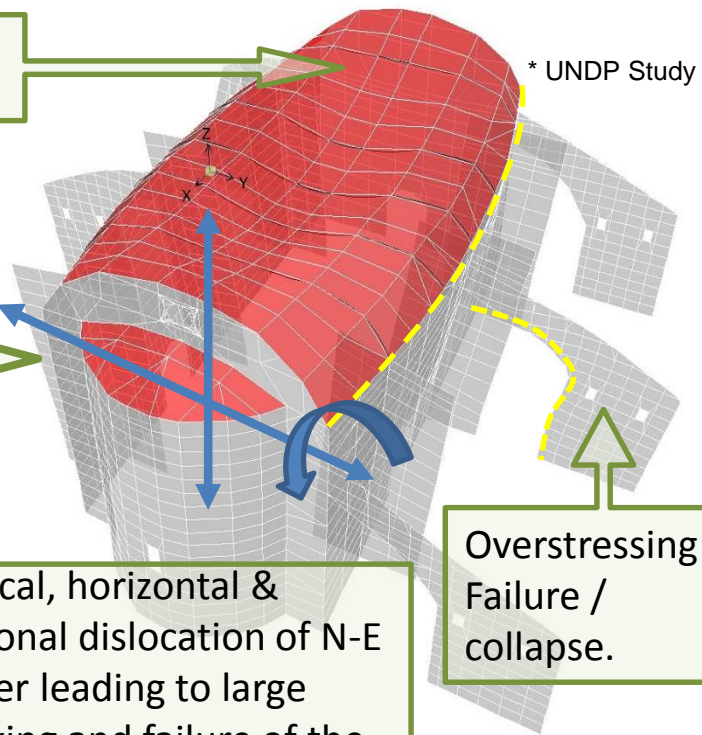
Poor diaphragmatic behavior

Some counterforts support / retain the buttresses while others the body of the church. That causes bad stiffness distribution making strong parts (corners) stronger and weak ones (middle body) even weaker.

Over-stretching of the arched roofing system – barrel vault action breached

Vertical, horizontal & torsional dislocation of N-E corner leading to large cracking and failure of the counterfort.

Overstressing - Failure / collapse.
