# Conservation of Mosque in Kalo Chorio/Vuda, Larnaca District UNDP CYP RFQ 210 2020

## Set of Condition Assessment drawings

Following the architectural survey, a detailed conditional assessment was carried out to document and assess the pathology of the structure. Both the minaret as well as the mosque itself were investigated in great detail for structural damage.

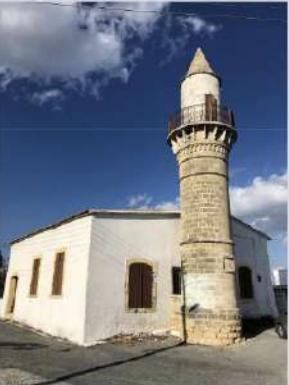
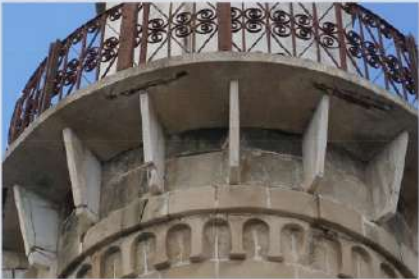
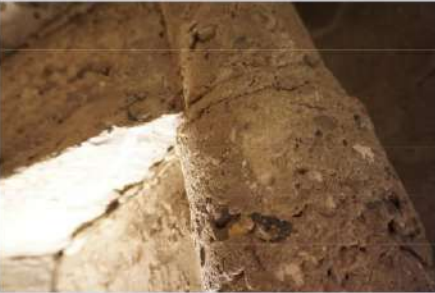
<p>PH. 5</p>	<ul style="list-style-type: none"> <li>• GENERAL   Laboratory testing must be carried out to specify material characteristics.</li> <li>• PH. 1 &amp; 5 – Damaged concrete elements &amp; Rusted steel elements   Deteriorated concrete must be fully removed until health surface is reached. Corroded reinforcement, if any, must be thoroughly cleaned and / or replaced where extensive damage or loss of section is observed. Protection paint should then be applied and final coating with high strength repairing mortar. Repairing of brackets supporting the platform. Existing rail to be thoroughly cleaned from rust, repaired where necessary and application of anti-corrosion epoxy paint system for protection.</li> <li>• PH. 2 – Rusted Lintel   Existing lintel steel elements to be thoroughly cleaned from rust. If remaining section is structurally sufficient, application of anti-corrosion epoxy paint system for protection should be carried out. If loss of section is observed, replacement should be done carefully and following specific and approved methodology.</li> <li>• PH. 3 &amp; 4 – Cracks on masonry wall / Deformed staircase stone axis   Structural tying of the minaret in specific levels to form a monolithical shaft section. All major cracks to be sealed with lime-based mortar injections.</li> </ul>

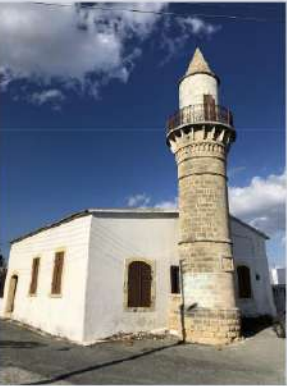
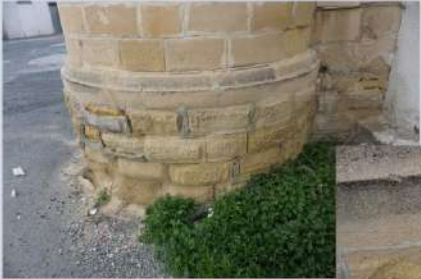
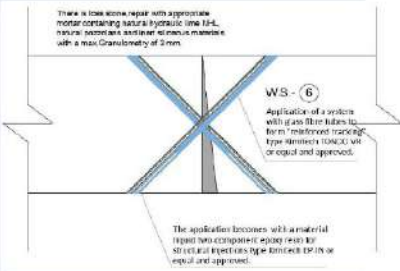
<p>PH. 11</p>	<ul style="list-style-type: none"> <li>PH. 6, 7 &amp; 9 – Deteriorated stone elements, missing stones and older cement interventions in the base   Removal of all cement repairs, replacement of stone elements where loss of section is significant, deep pointing &amp; jointing of the entire base, structural tying / capping of the base either by tie rods or stitching techniques.</li> <li>PH. 8 – Cracked lintel on both ends   Existing lintel steel elements to be thoroughly cleaned from rust and protected with anti-corrosion epoxy paint system. Further strengthening of the opening by installing glass fiber tubes or s/s bars anchored in a crossing form with the use of epoxy resin.</li> </ul>

<ul style="list-style-type: none"> <li>PH. 10 &amp; 11 – Weak damaged plaster &amp; missing wall parts   Cement repairs to be removed, weak plasters to be removed as well, stone members to be repaired or replaced depending on damage extend, cracks treated accordingly, deep pointing and jointing to be carried out, lime plaster to be applied where necessary.</li> </ul>

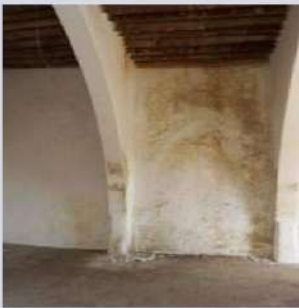
<ul style="list-style-type: none"> <li>PH. 19 – Strengthening of the buttress section near the base or full reconstruction, water drainage system (gutters / downpipes) on the roof to avoid water flow on the wall.</li> <li>PH. 20 &amp; 21 – Cracked floor slabs   Floor to be repaired. Floor slabs to be removed, slab on grade and tie beams to be constructed, floor slabs to be put back in place, replacement of those who are cracked and damaged. Joint sealing.</li> <li>PH. 22 – Deformed roof joists   All roof joists must be removed and replaced. Wooden tie beams must be introduced at the top of both supporting walls.</li> <li>PH. 23 – Heavily moistened east wall   Damaged wall plaster to be replaced, proper water drainage system (gutters / downpipes) on the roof to avoid water flow on the wall and water penetrating inside.</li> </ul>

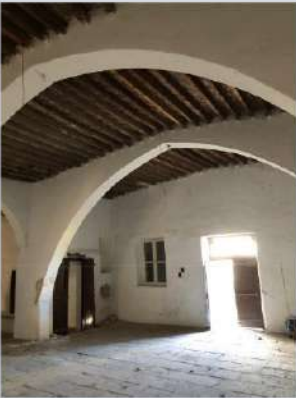
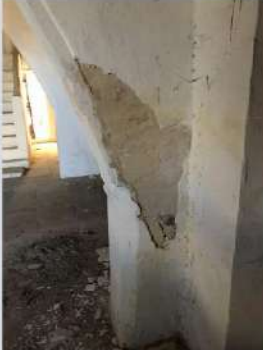
<p>PH. 29</p>		<ul style="list-style-type: none"> <li>• PH. 24 – Weak swollen plaster   Plasters to be removed, inspection of wall and cracks treated accordingly, deep pointing and jointing to be carried out, lime based plaster to be applied where necessary.</li> <li>• PH. 25 – Detached plaster and damaged masonry   Damaged adobe wall to be replaced or strengthened with the use of wooden wedges and planks, plaster replacement.</li> <li>• PH. 26 – Wall structure disorganized and absence of homogeneity   Plaster to be fully removed, wall to be cleaned thoroughly and deep pointing and jointing to be carried out in order to form a bonded wall section. Stitching to be performed at all corners and T-junctions.</li> <li>• PH. 27 – Existing wooden lintel   Wooden beams in a fairly good condition. Wooden sections to be treated and protected properly with suitable protective paint.</li> <li>• PH. 28 &amp; 29 – Stone arch cracked edge   Strengthening and restoring measures to be applied. Replacement of stone elements where loss of section or structural deficiency is significant, structural tying of the stone arched frame either by tie rods or stitching techniques. Finally, deep pointing and jointing.</li> </ul>

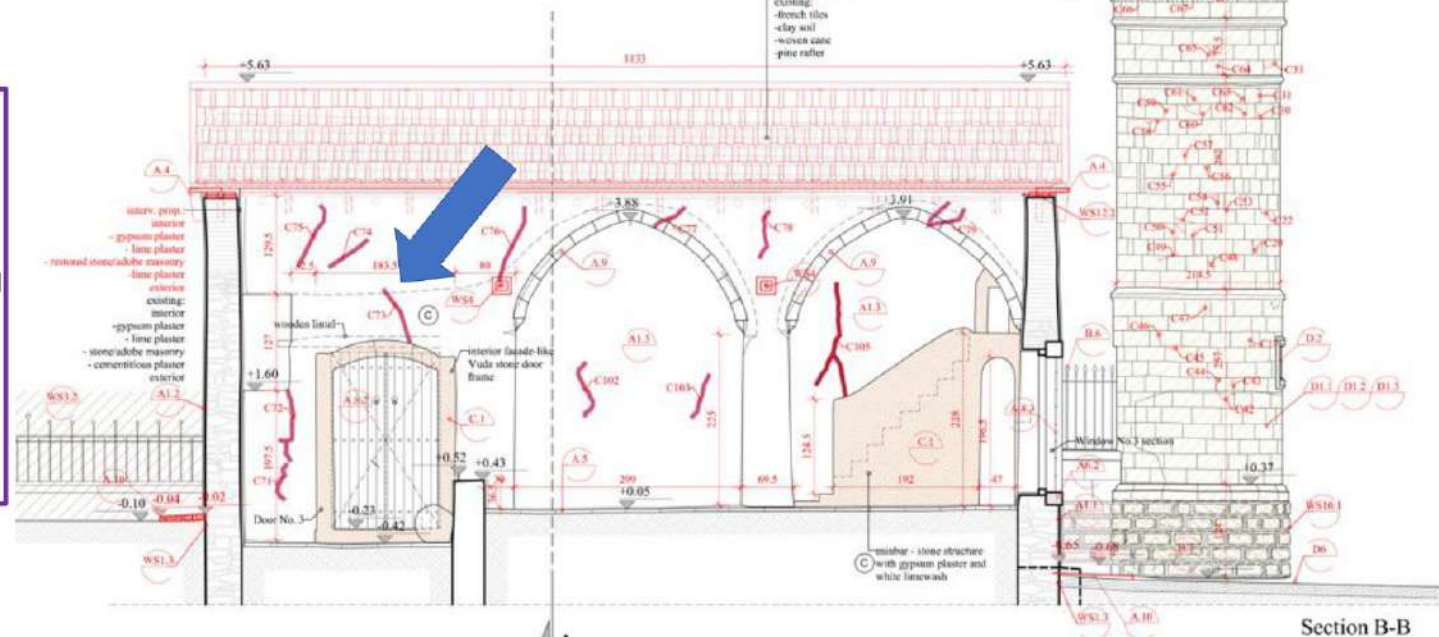
Section B-B

→ Cracks over opening keys indicates wall separation in corners

→ Removal of existing external incompatible cement plaster and swollen internal plasters

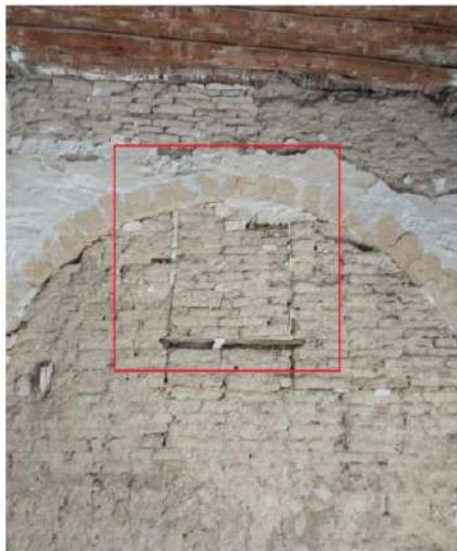
Photo – 2: Founding of larger window that will be strengthened with two (2) timber ties.

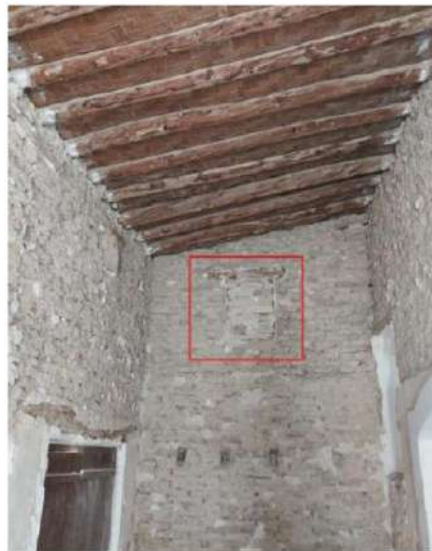
Photo – 3: Founding of small window that will be strengthened with one (1) timber tie.

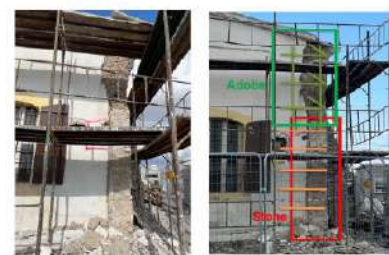
Questions were raised concerning the South-East corner stitching detail which must be revised after the discovery of the new hidden arch. After the removal of the interior plaster and some of the arches, the pier of the arch was found to made of stone units, contrary to the adobe wall that was given in the drawings.

Photo – 8: Existing S.E. corner wall typology - bottom half part made of stone masonry, upper half part made of adobe masonry

- The Designer advised that the crack stitching detail as per W6.2 is not appropriate for the bottom part of the wall that is made of stone masonry, but only for the upper half which is consistent of adobe bricks.
- It was stated that a new detail will be sent the following day (Sketch – 3).
- The Designers clarified that the upper half part will be repaired as per W6.7.1 and W6.7.2 according to the detail of the installation of timber corner elements internally for bonding of the adjacent walls and the stitching of the deep crack externally with timber vertical and horizontal elements.
- Additionally, for the lower stone masonry wall, galvanized steel threaded de rods of 8-16 mm will be installed every 35 cm vertically with special grouting injection of M40 material, as per detail attached (Sketch – 2).
