20-21 October 2021, Sofia, Bulgaria

International Conference on Earthquake Engineering

The need for Assessment and Seismic Strengthening of Existing Buildings in parallel with Energy Efficiency Improvements – A case study from Cyprus.

10. Example of Seismic/Structural Update of a Building (Cyprus).

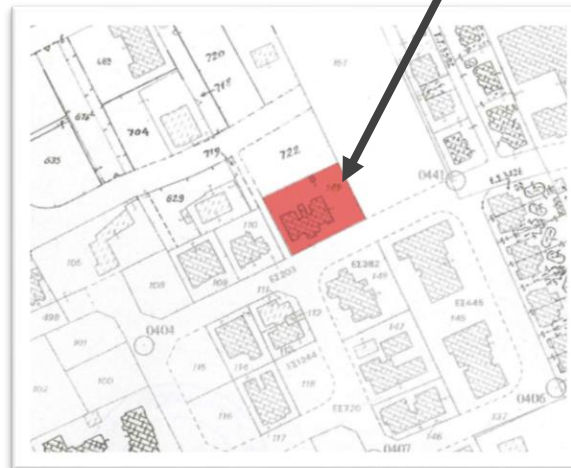
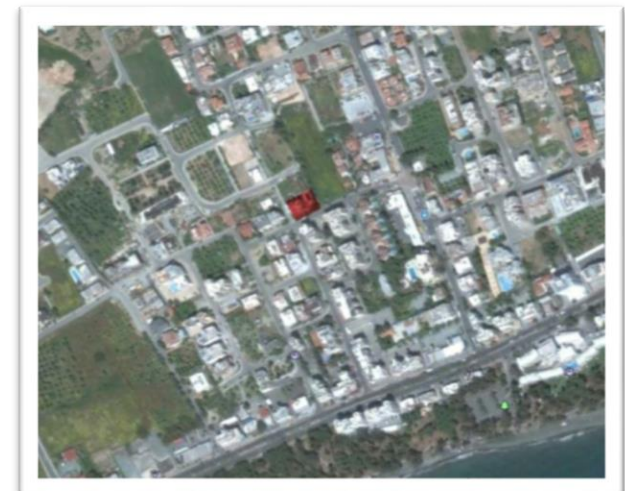
Building under
assessment

- The building is situated in Germasogeia Limassol, Cyprus.
- Building was constructed circa 1980.
- The existing building consisted of ground floor (used as utility area) and five more floors above and was serving as a small business hotel.

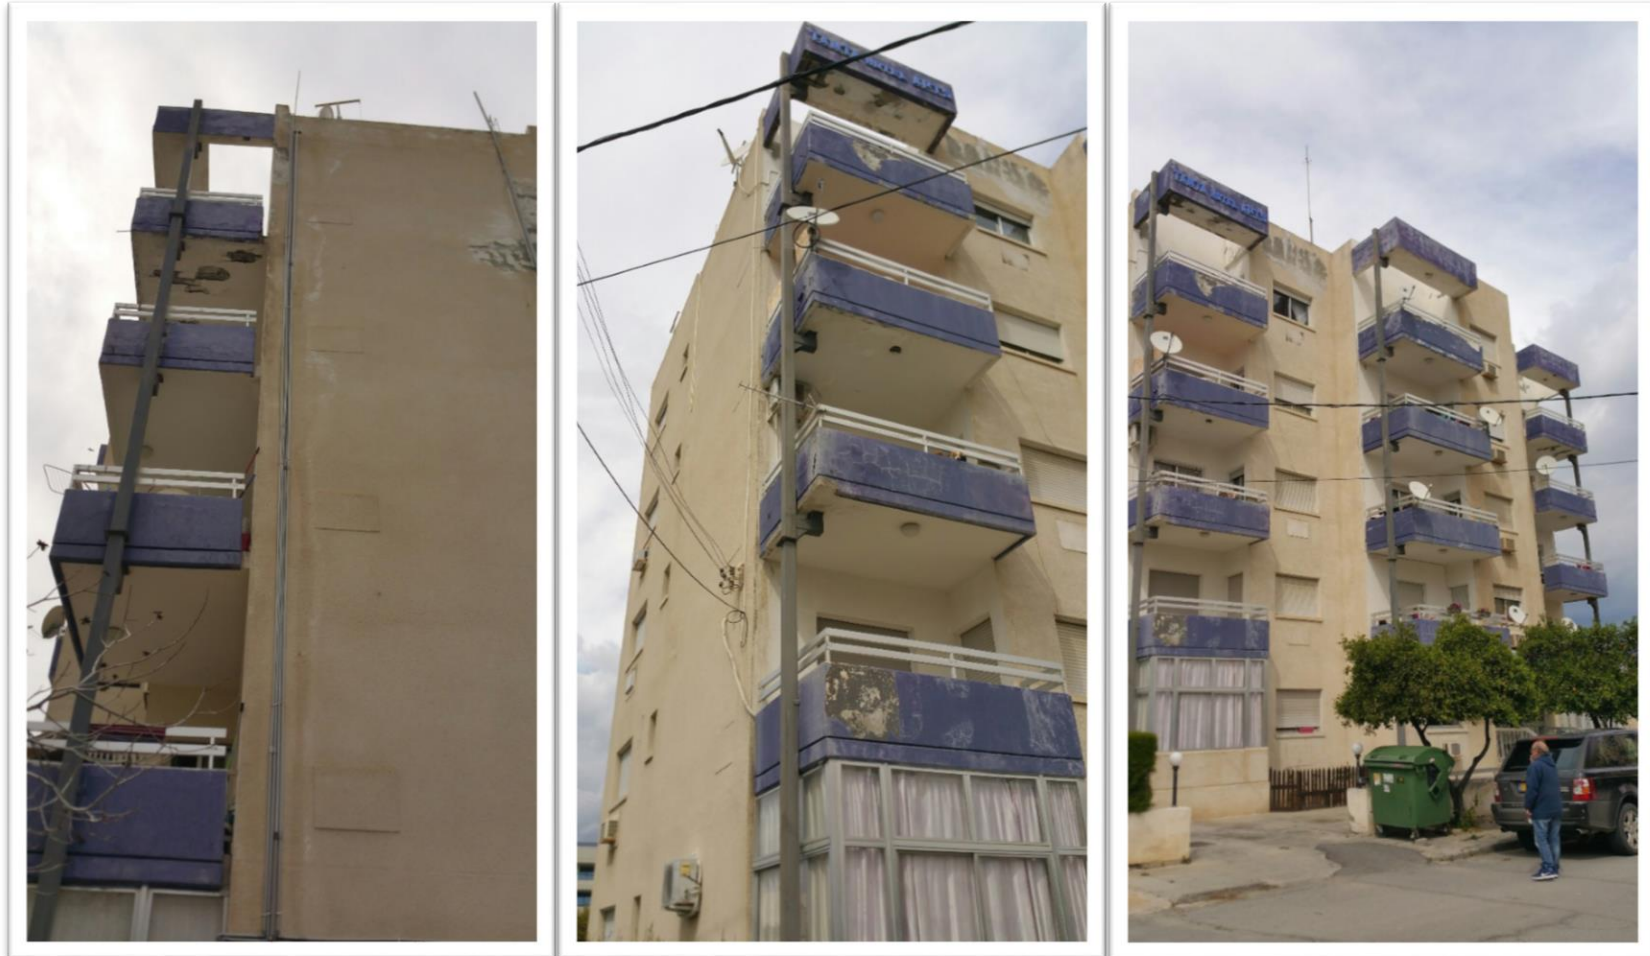
- The situation of the building before strengthening.

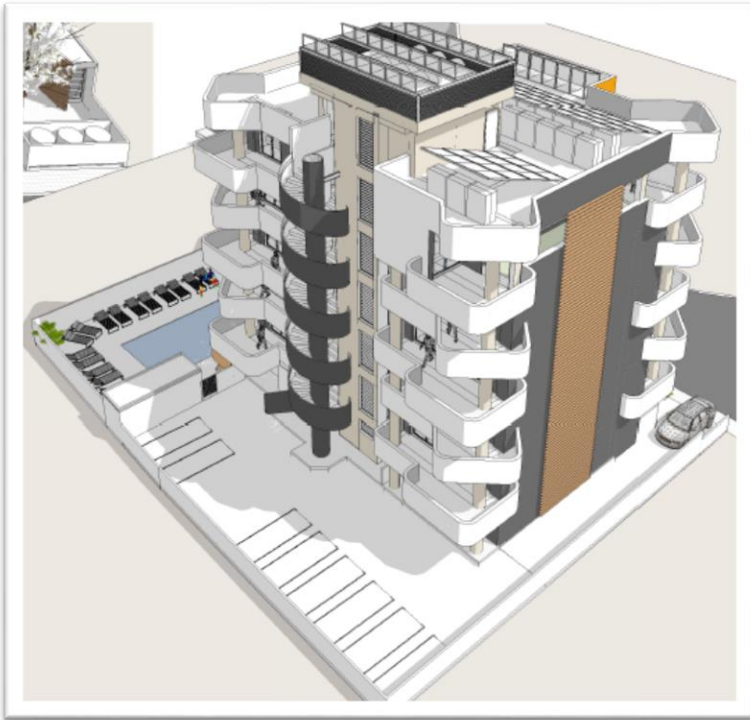
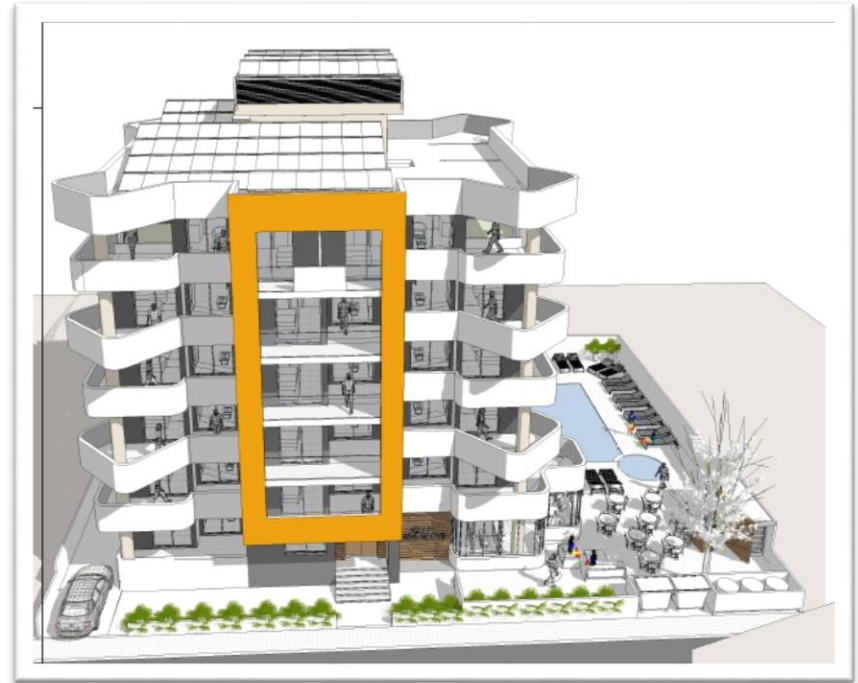
- 3D Drawings of the proposed renovated building, energy upgraded and with the addition of an extra floor.

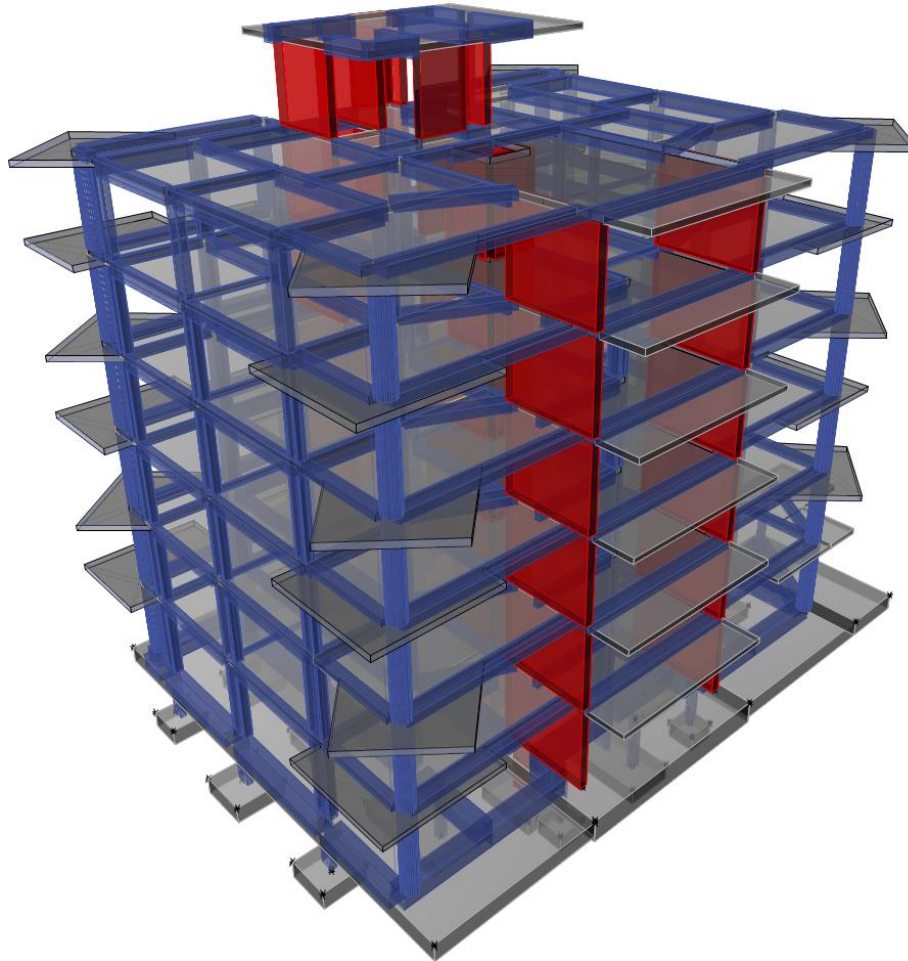
Figure 1: 3D Model Idealization

The structure was modelled using linear elements for RC beams and columns and shell elements for shear walls and RC slabs. Regarding the foundation system, fixity was assumed at the element bases. Overall dimensions, element sections and material properties included in the analysis model, were based on the survey drawings and findings, the photos taken on site and the laboratory results.

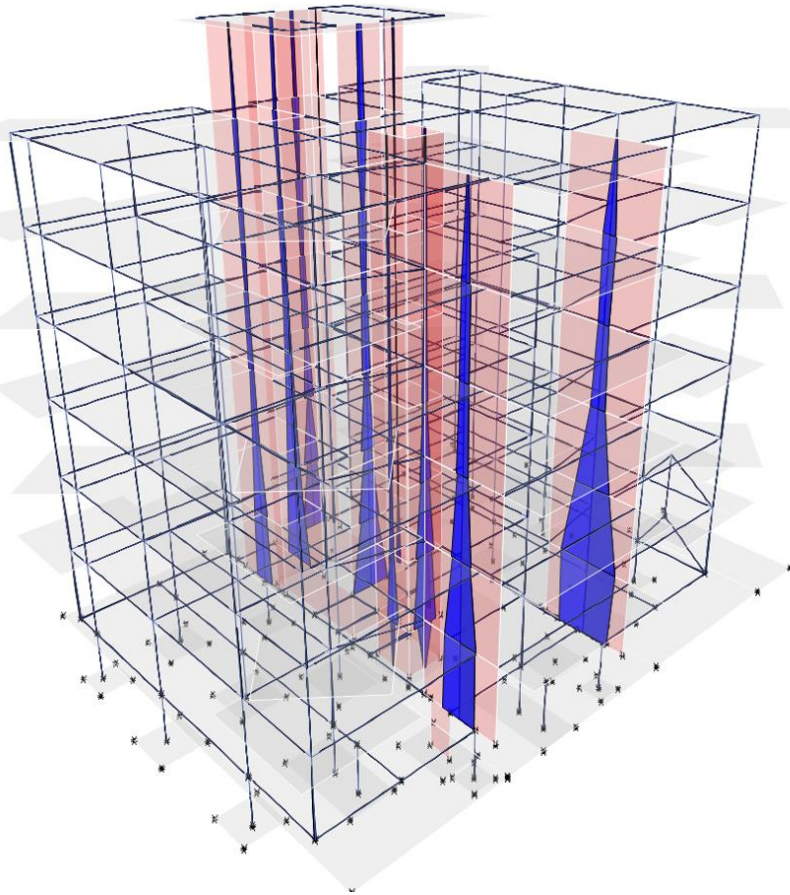
Figure 5: Pier Element main moment Range under U.L.S. Earthquake Combination in main X-direction.

The building was designated together with the client to be of importance class II and hence **the design ground acceleration (0.25g) was multiplied by a factor of 1 according to the EC8 recommendations. Further to this, the material damping was set as 5% and the soil class was taken to be class B.**

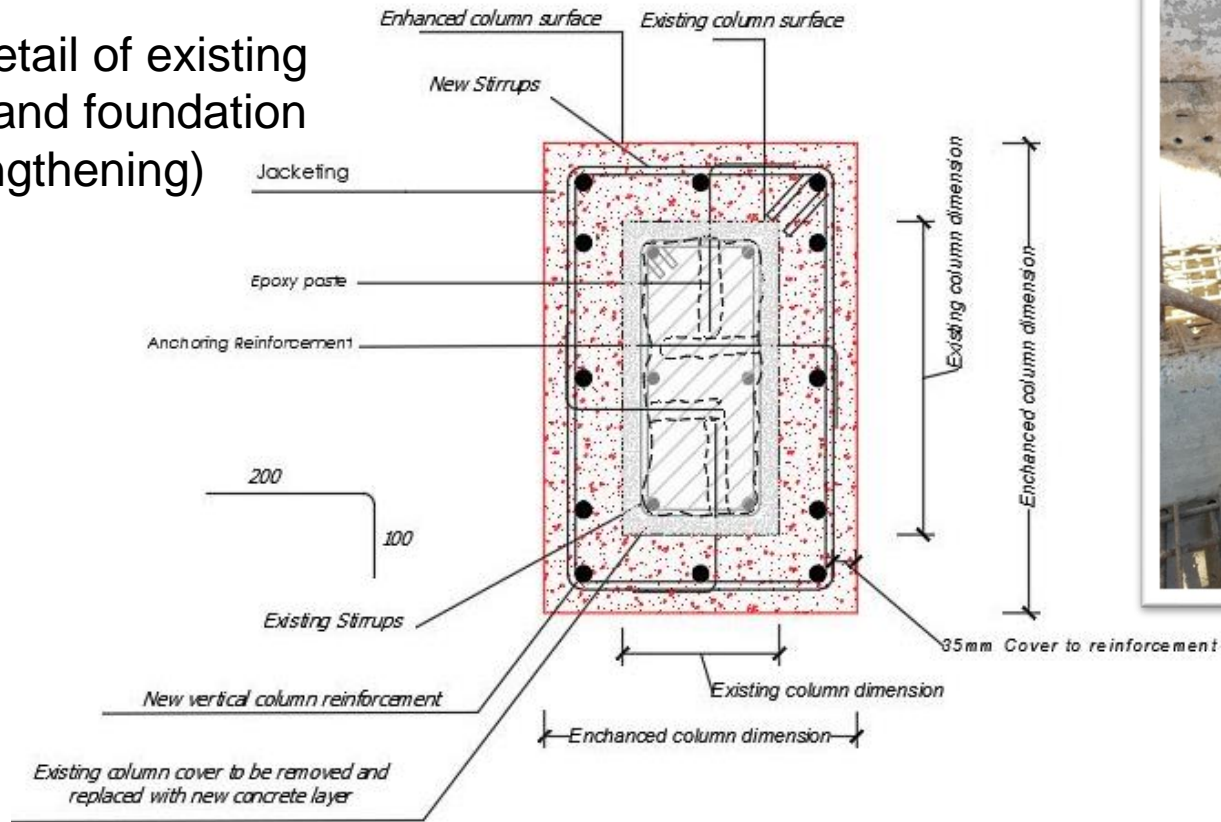
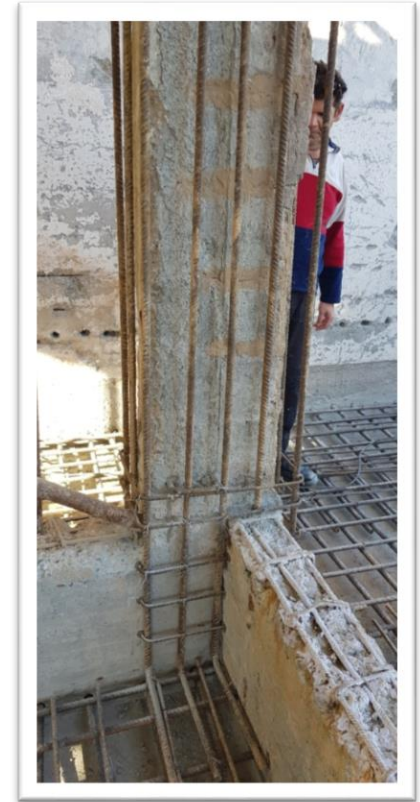
STRENGTHENING OF THE EXISTING BUILDING

(Jacketing Detail of existing columns and foundation strengthening)

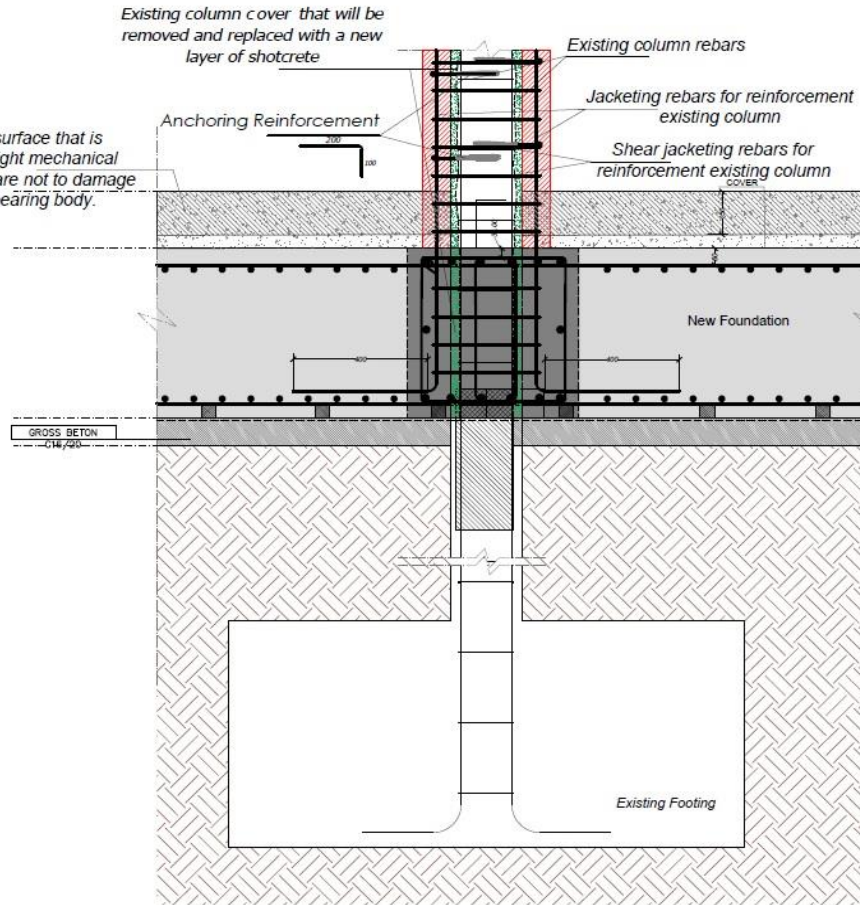
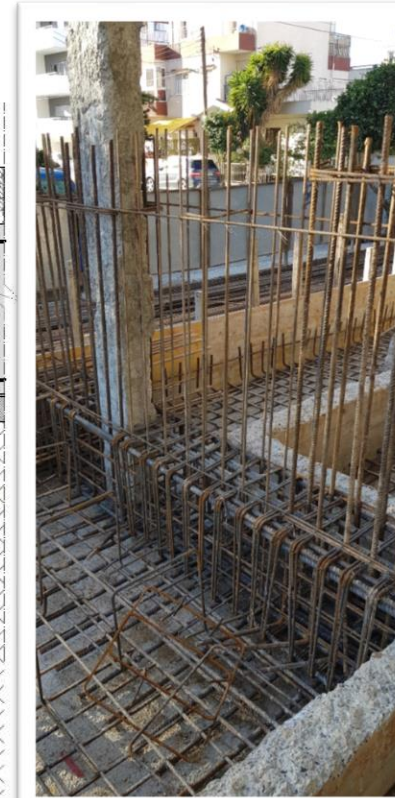
STRENGTHENING OF THE EXISTING BUILDING

(new mat foundation which encased existing ground beams)

Existing slab surface that is demolished by light mechanical means and with care not to damage the existing bearing body.

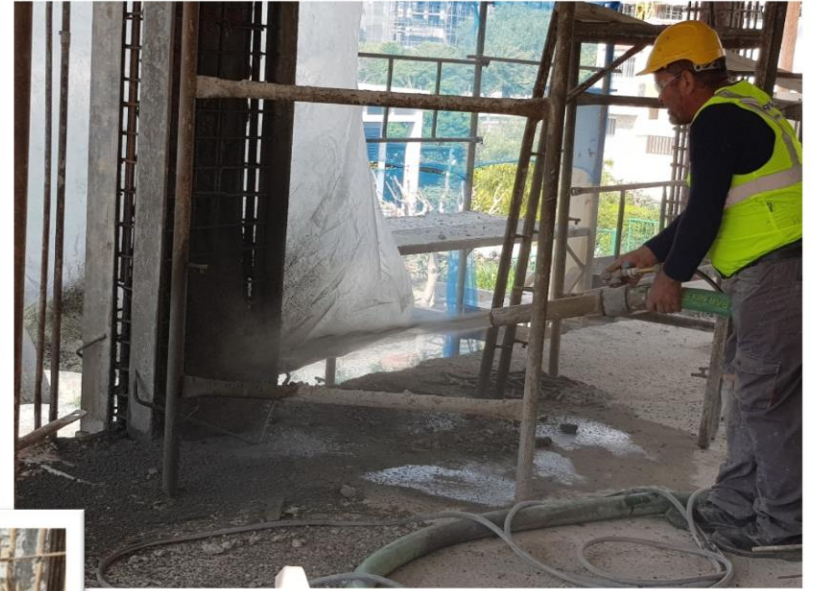
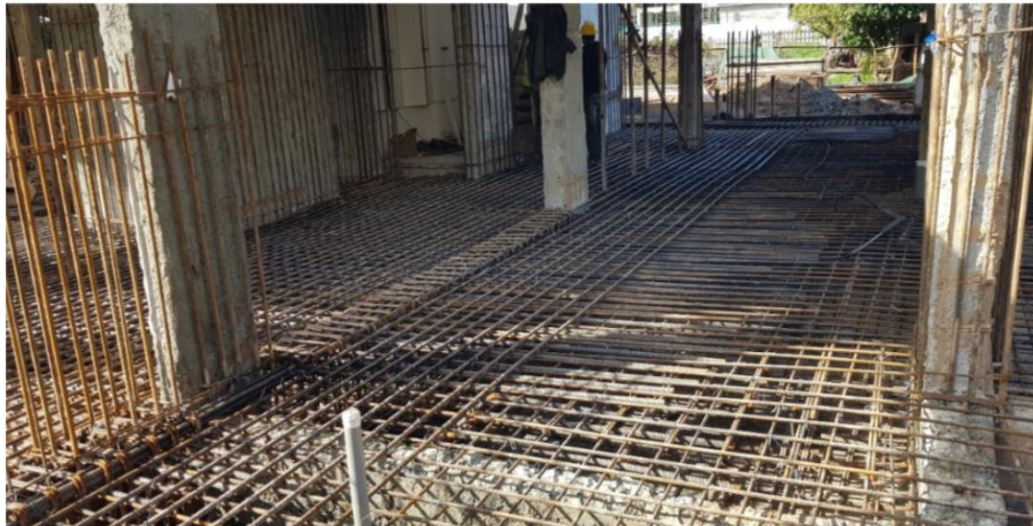
STRENGTHENING OF THE FOUNDATIONS OF THE EXISTING BUILDING

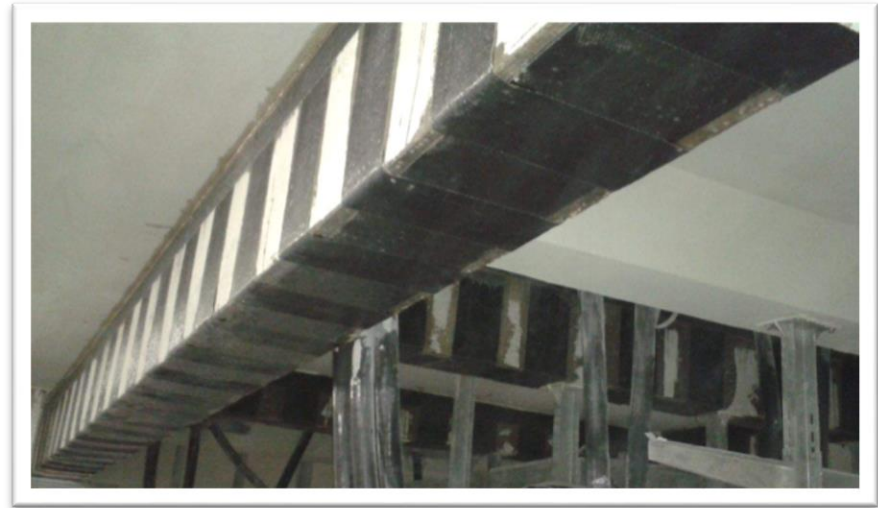
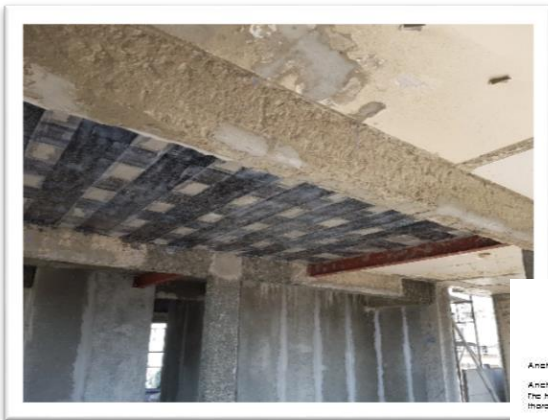
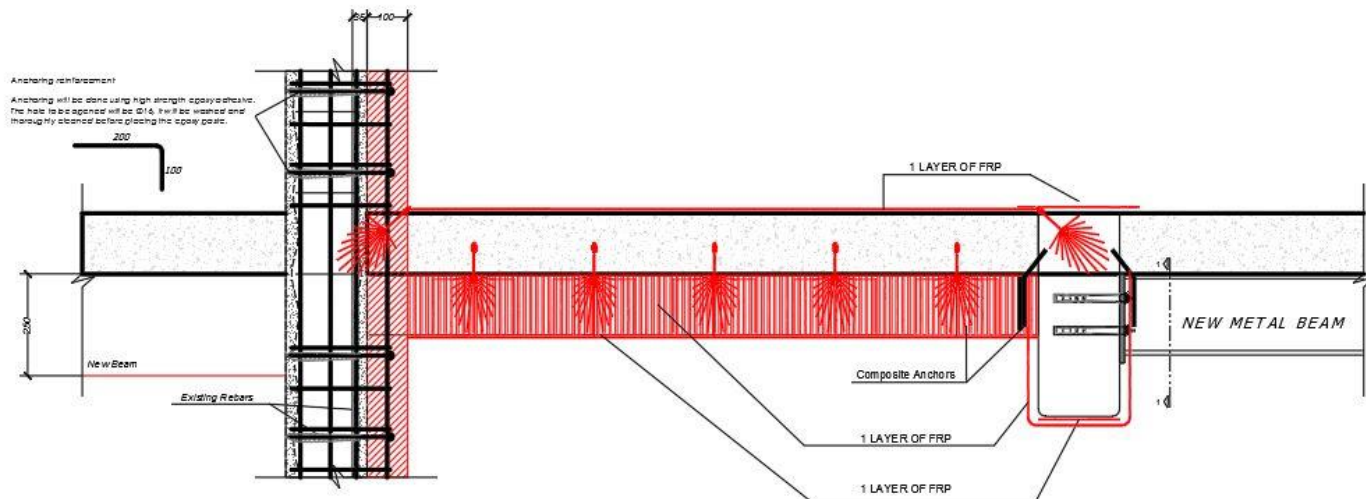
STRENGTHENING OF THE EXISTING BUILDING

(Fibre Reinforced Polymers (FRP) - strengthening of beams /slabs)

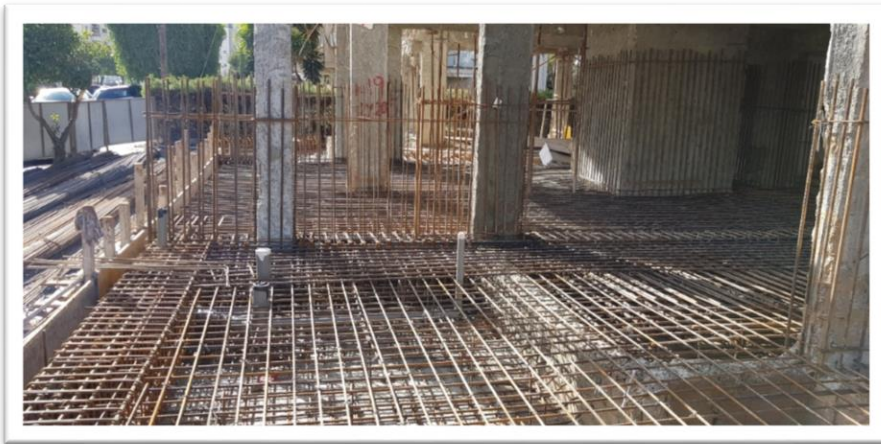
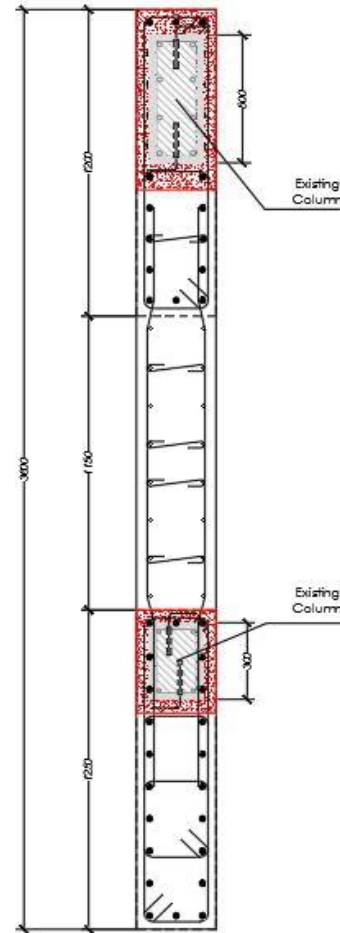
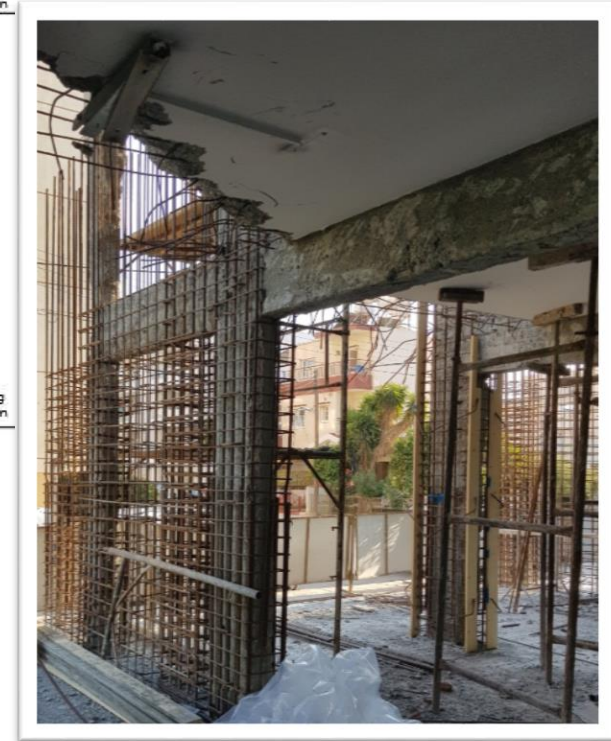
STRENGTHENING OF THE EXISTING BUILDING

(formation of shear walls from existing columns)

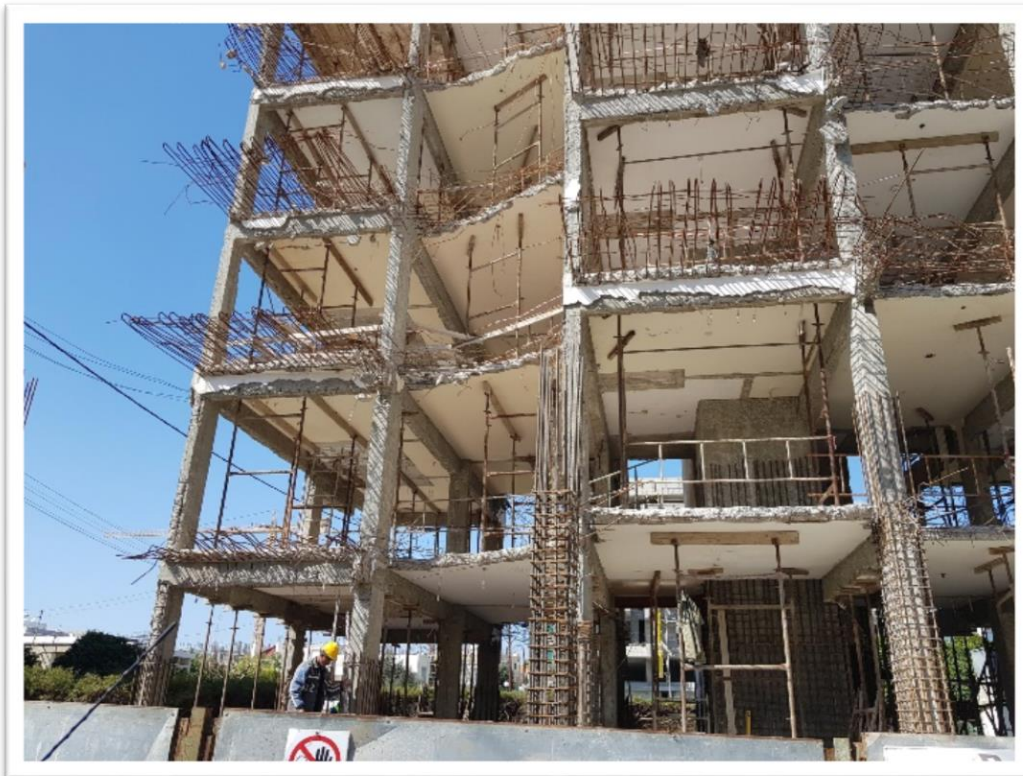
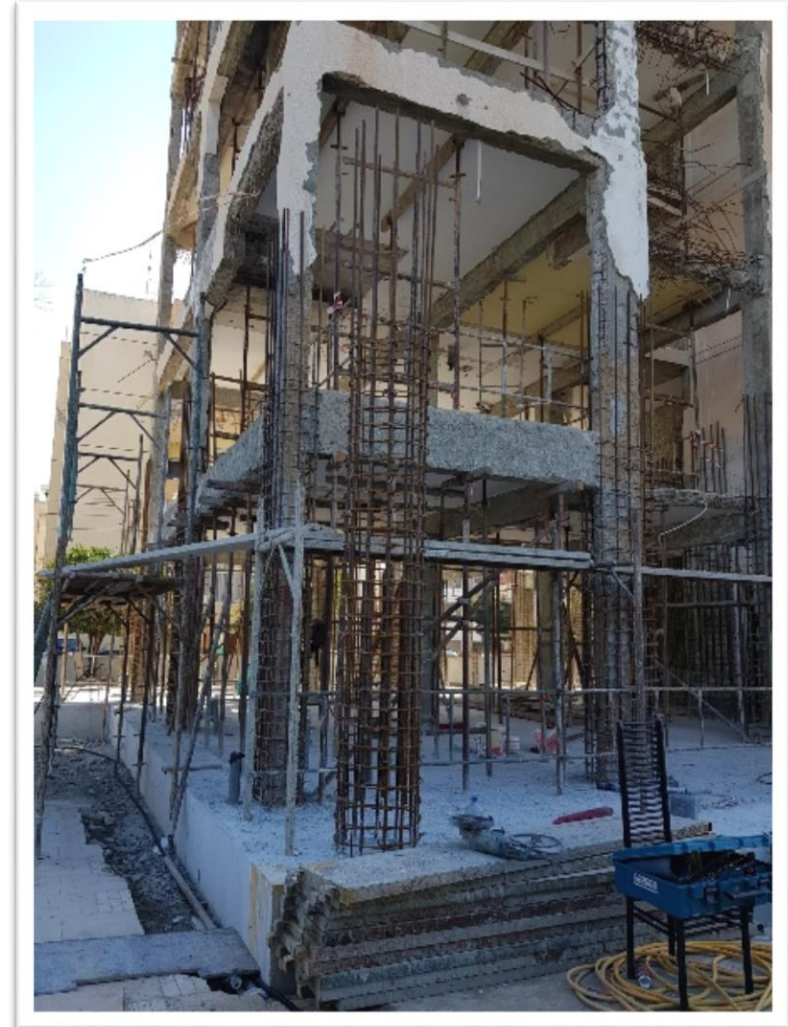
STRENGTHENING OF THE EXISTING BUILDING

(Jacketing Detail of existing columns)
