Ο ΑΝΕΜΟΜΥΛΟΣ ΣΤΑ ΛΗΜΝΙΑ ΑΜΜΟΧΩΣΤΟΥ

Ένα μνημείο τεχνολογίας, περιβάλλοντος και πολιτιστικής κληρονομιάς

CONSERVATION STUDY

12. Building Pathology and Damage Diagnosis report

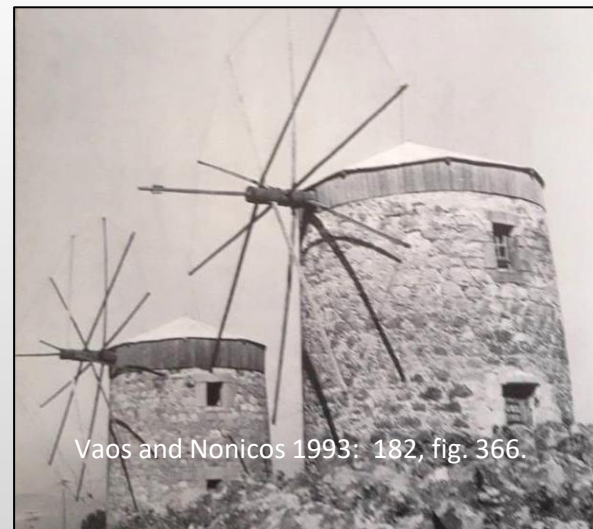
Ξύλινες Οροφές

Το πλαίσιο της οροφής κατασκευαζόταν από ξύλο και καλυπτόταν με ξύλινες σανίδες. Οι οροφές ήταν είτε κωνικές είτε τετράπλευρες πυραμιδοειδείς.

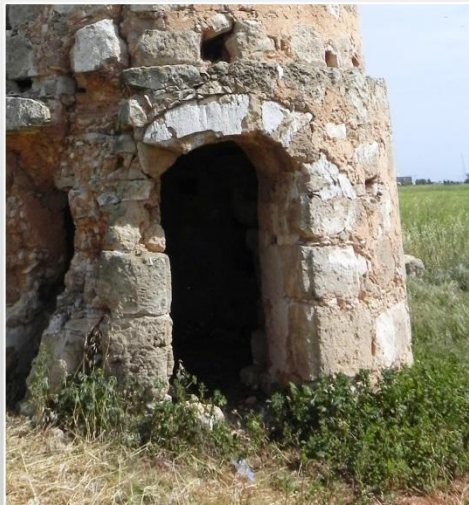
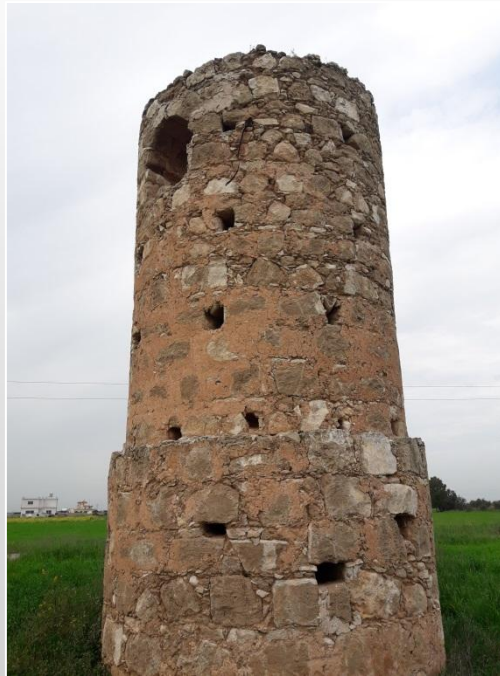
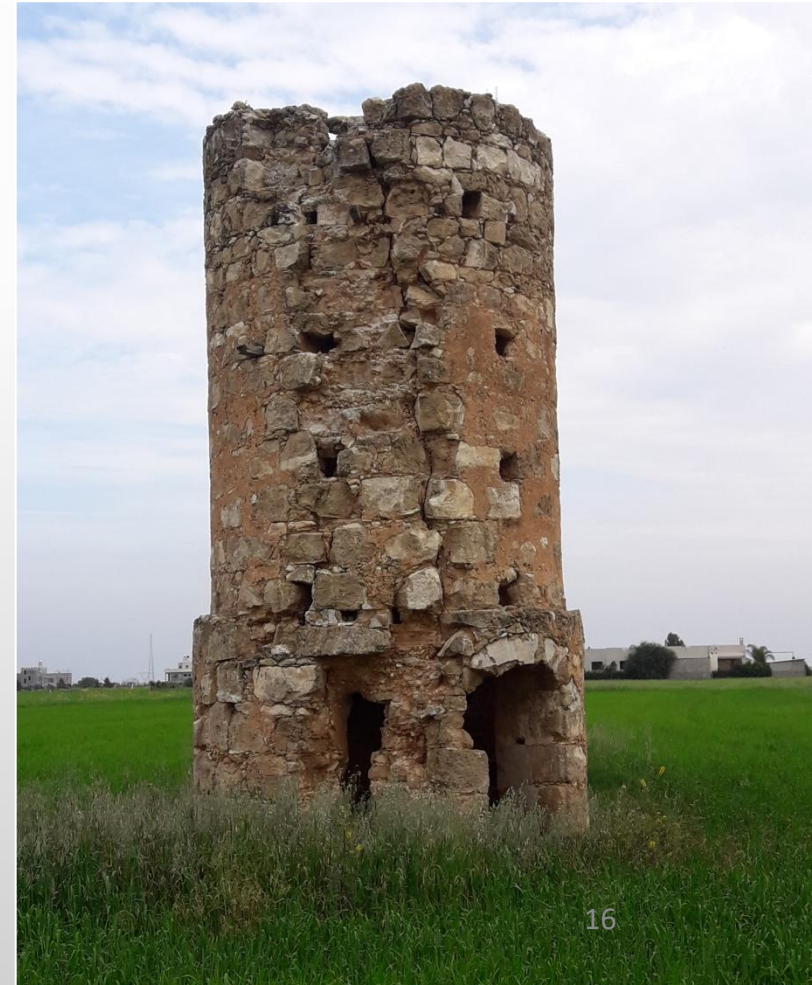
- Χαρακτηριστική κυλινδρική λιθόκτιστη κατασκευή.
- Ευρύτερη βάση για μεγαλύτερη σταθερότητα.
- Η είσοδος βρίσκεται στη νοτιοδυτική πλευρά και διαμορφώνεται με λίθινο τόξο.
- Μικρά ανοίγματα και παράθυρα βρίσκονται στη νοτιοανατολική πλευρά.
- Η κατασκευή έγινε με ντόπια υλικά με τοπική πέτρα και παραδοσιακά κονιάματα.

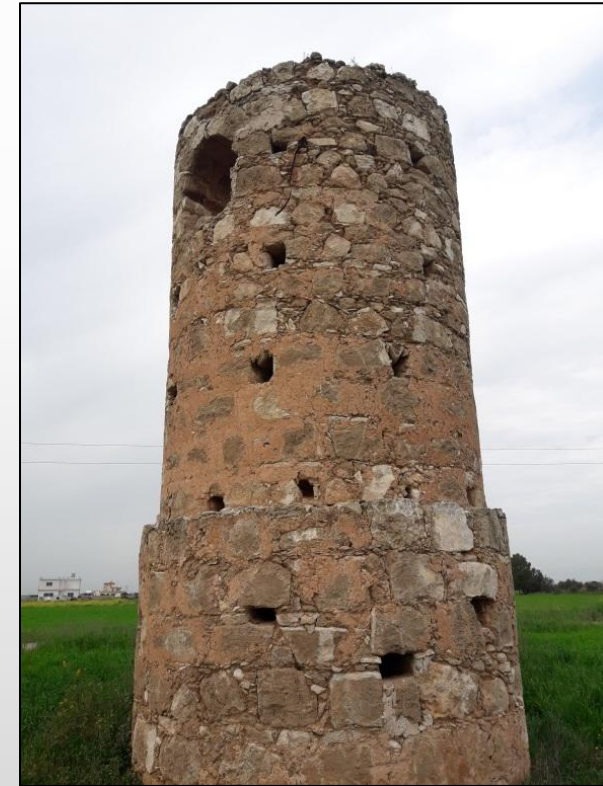
Οροφή: κωνική αχυροσκεπής κατασκευή με ξύλινο σκελετό?

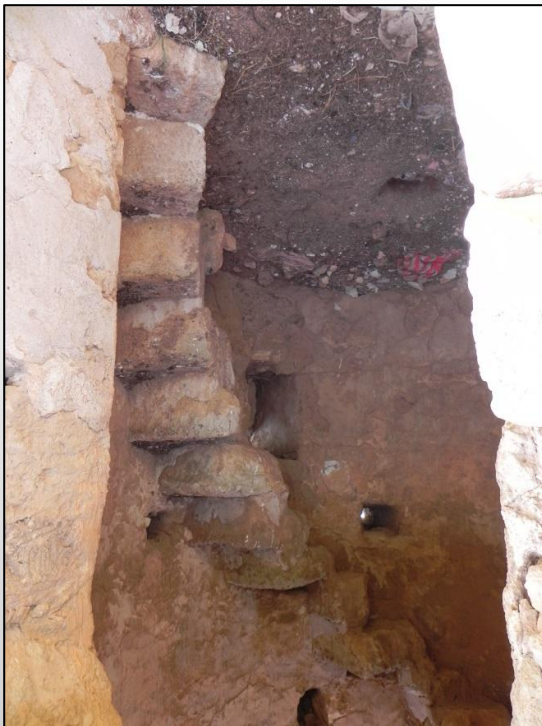
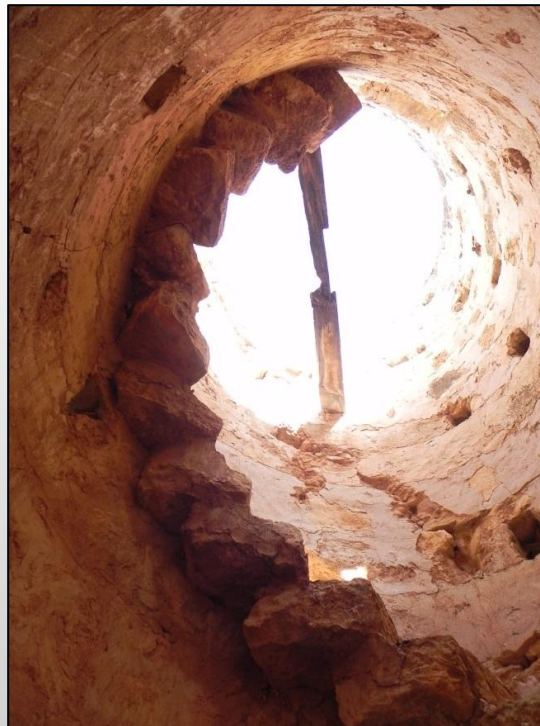
- Ενσωματωμένες πέτρινες σκάλες μέσα στους τοίχους οδηγούσαν στους ανώτερους ορόφους.
- Πιθανότατα διέθετε τρία επίπεδα: ισόγειο, ενδιάμεσο όροφο και ανώτερο όροφο.
- Στον ανώτερο όροφο βρισκόταν ο μηχανισμός άλεσης.
- Η αρχική οροφή δεν διασώζεται, αλλά πιθανότατα ήταν κωνική και καλυμμένη με άχυρο.
- Δεν έχουν διασωθεί στοιχεία του αρχικού μηχανισμού λειτουργίας, ο οποίος πιθανόν αφαιρέθηκε όταν χρησιμοποιήθηκαν νεότερες μηχανές άλεσης.

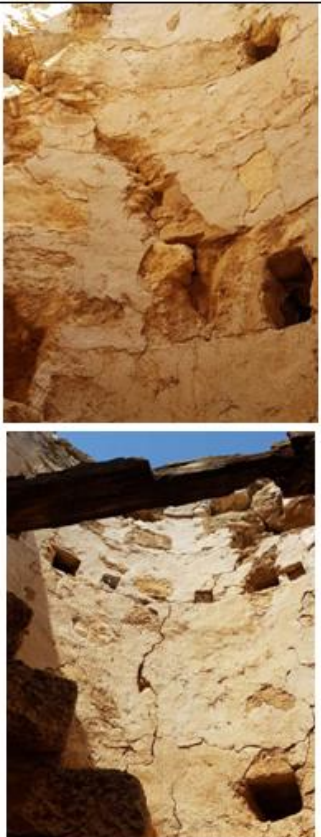
Stone masonry walls/Joining mortar			
Code	Damage description	Representative photo	Possible cause of deterioration/damage
SC	Structural cracks

<p>Severe cracks are located at the interior of the windmill are probably due to:</p> <ul style="list-style-type: none"> The partial collapsed masonry wall on the outside surface. The various openings, cracks are govern to the weakest points.

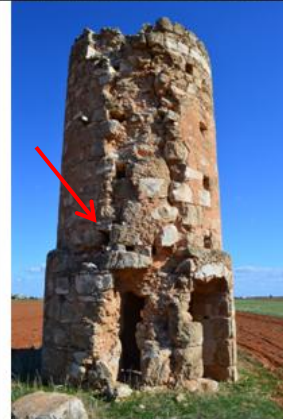
<ul style="list-style-type: none"> Probably caused during an intervention to re-adjust the masonry walls in order to transform old windmill to a steam gridding mill.
PCW	Partial Collapsed wall

<ul style="list-style-type: none"> Local loss of the outer stone layer with the rest of the three-layered masonry. Probably cause by: <ul style="list-style-type: none"> Absence of a diaphragmatic (box) behavior. Horizontal movements generated by earthquakes. The structure is positioned on soft soils with a ground acceleration of 0,25g (Seismic zone III) which makes it vulnerable to high intensity earthquakes.
BC	Biological colonization (Black stains)

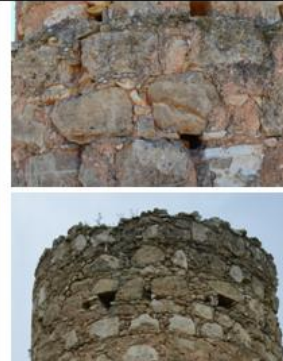
<ul style="list-style-type: none"> Signs of black stains on the surface of the stone wall implies humid conditions. Since there is no roof to cover the windmill, rain water runs off on the exposed masonry walls. These spots turn the original surface material darker and are often accompanied by biological growth i.e. moulds.

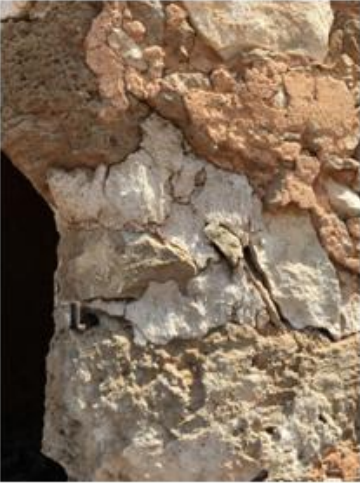
<ul style="list-style-type: none"> Vegetation is growing at the top of the free standing masonry walls. Signs of vegetation implies humid conditions at the top level of the structure. Organic material is trapped in the porous of the stone/rubble material in combination with the presence of humidity encourages plants to thrive (see Biological colonization).
DMR	Decayed of jointing mortar/rendering.

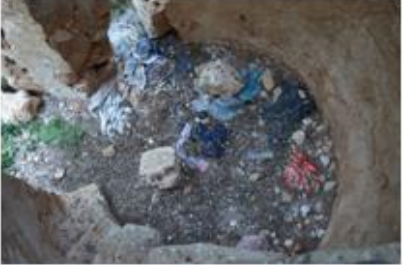
D	Debris

<ul style="list-style-type: none"> Lack of maintenance and abandonment of the place. The interior floor of the windmill is covered with plastic debris.
W	Well

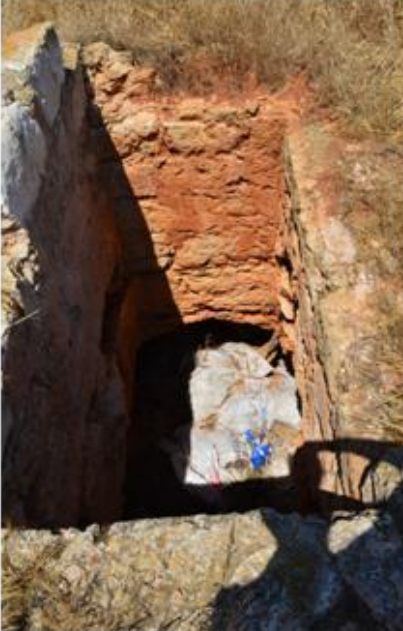
<ul style="list-style-type: none"> Lack of maintenance and abandonment of the place. The well is full of debris and dead decomposed animals.

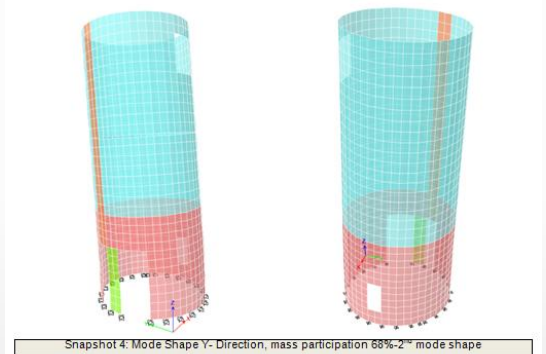
Snapshot 4: Mode Shape Y- Direction, mass participation 68%-2nd mode shape

The 2nd **mode shape** is the **dominant y-direction** mode shape with participation of mass 68% (snapshot 4). There is no significant deviation from the X-direction, this is expect due to the cylindrical shape of the windmill. However, the slight difference in mass participation is mainly due to the fact that there is no openings on the Y-direction, so the entire body of the structure is resisting when subjected to a seismic load.

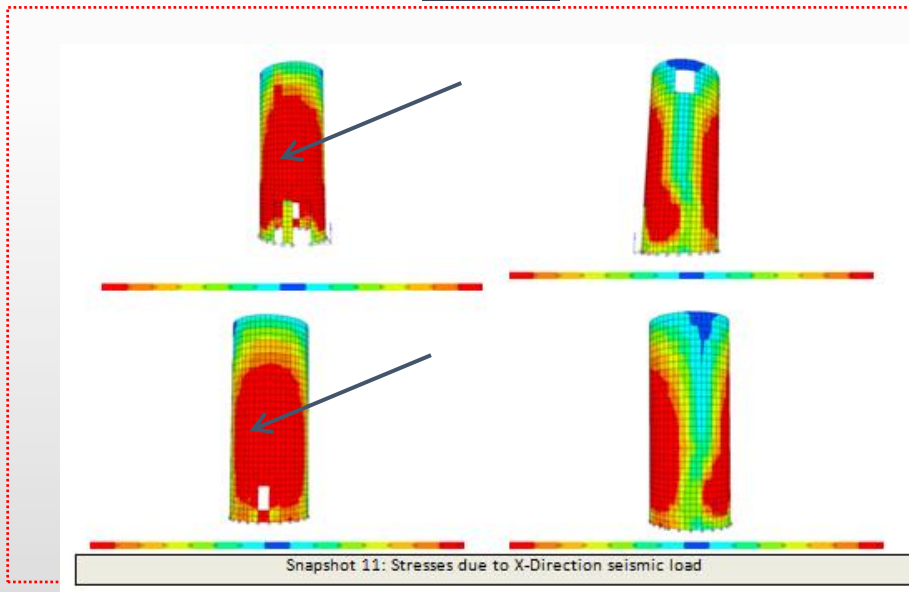
Shear stresses due to seismic loads
X-Direction

Depending on the examined direction, **significant shear stress values** (colored in red) are observed in all the directions of the windmill and at the openings. This is mainly due to the cylindrical shape of the windmill. This is a really common behavior; since the stresses are govern to the weakest parts of the structure where big openings are located.

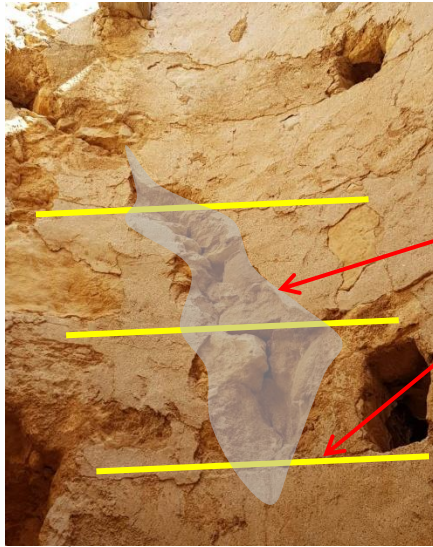
Healing of cracks using the stitching method accompanied with stone stitching and grouting injections

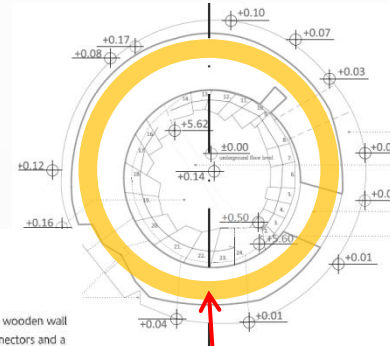
wooden joist 15x7.5cm
wooden peg (pole) $\varnothing 3 \times 40$ cm
drilling will proceed with a 28mm diameter drill.

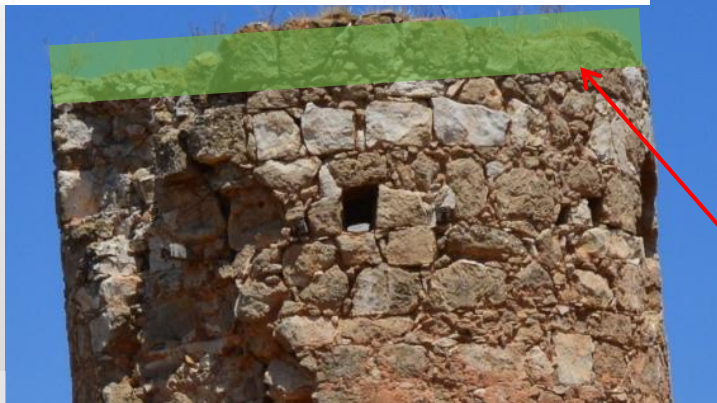
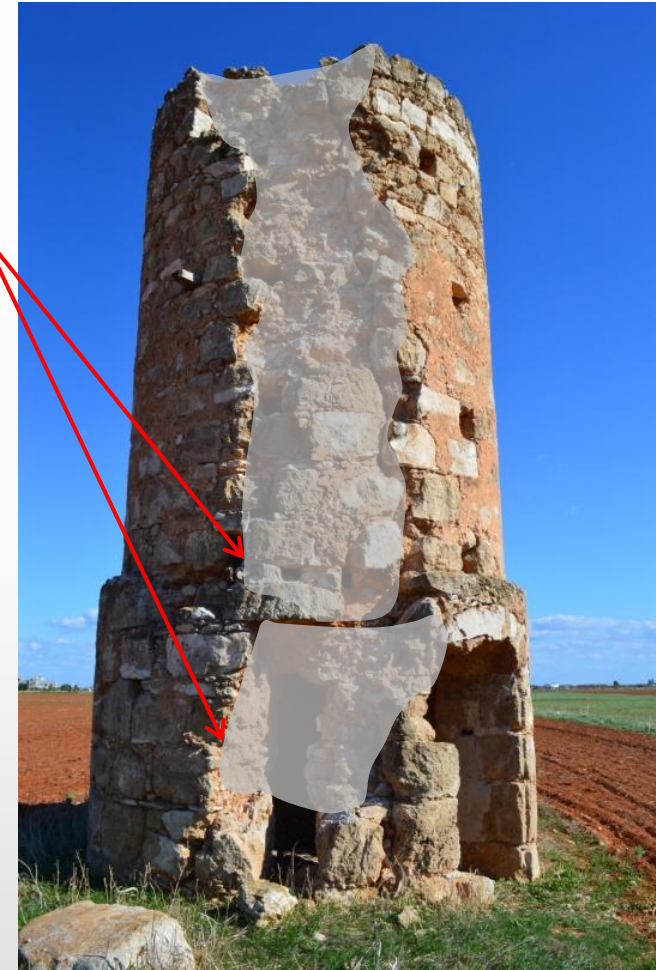
Alternative two wooden wall plates with connectors and a plate.

Provide a stiff connection at the roof level by installing a wooden boundary ring beam above the stone masonry walls in order to ensure a diaphragmatic rigidity when subjected in lateral forcing.
