# Ο ΑΝΕΜΟΜΥΛΟΣ ΣΤΑ ΛΙΜΝΙΑ ΑΜΜΟΧΩΣΤΟΥ

Ένα μνημείο τεχνολογίας, περιβάλλοντος και πολιτιστικής κληρονομιάς

## CONSERVATION STUDY

**Joint Venture:**  
**Platonas Stylianou & Associates, Civil and Structural Engineers L.L.C &**  
**Architect firm Chrysanthos Pissaridis**

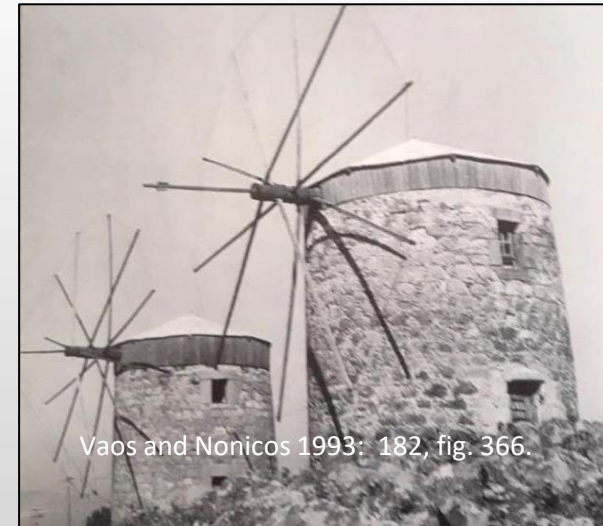
Το πλαίσιο της οροφής κατασκευαζόταν από ξύλο και καλυπτόταν με ξύλινες σανίδες. Οι οροφές ήταν είτε κωνικές είτε τετράπλευρες πυραμιδοειδείς.

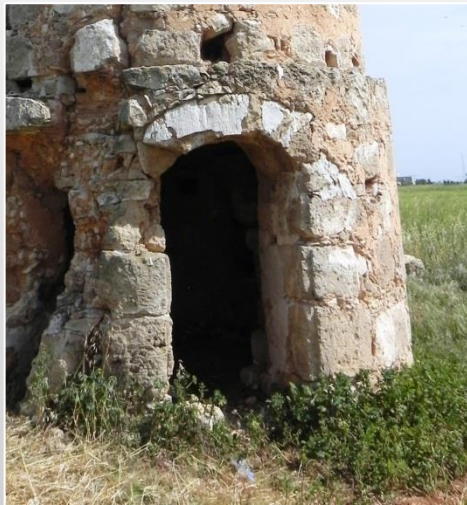
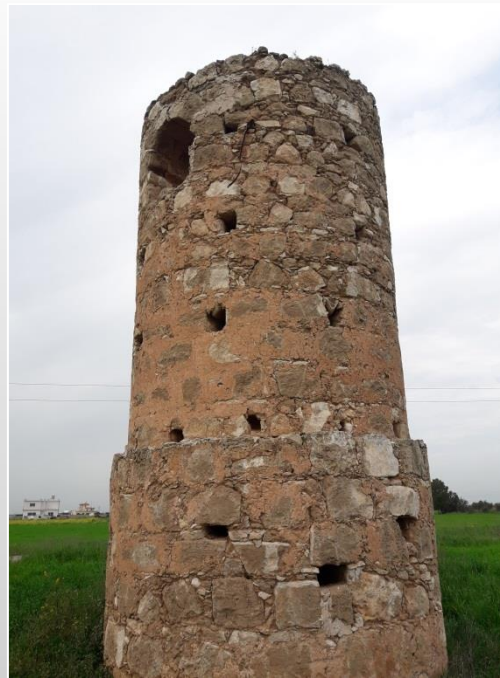
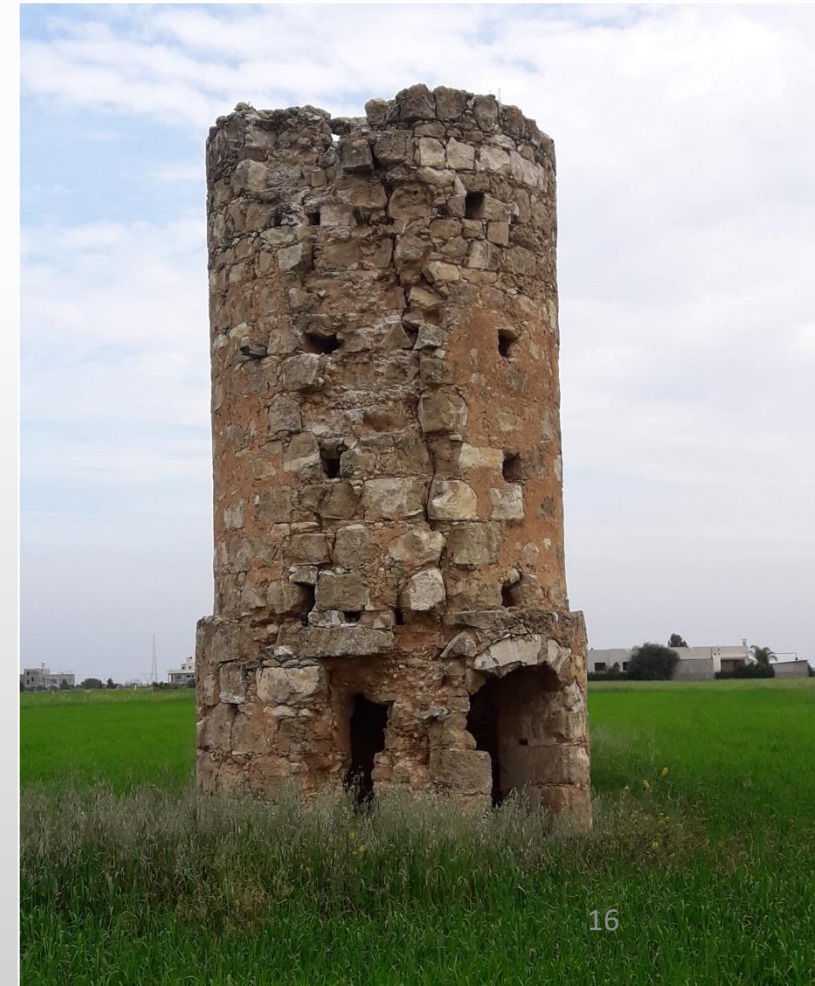
## 9. Αρχιτεκτονικά Χαρακτηριστικά του Ανεμόμυλου Λιμνιών

- Χαρακτηριστική κυλινδρική λιθόκτιστη κατασκευή.
- Ευρύτερη βάση για μεγαλύτερη σταθερότητα.
- Η είσοδος βρίσκεται στη νοτιοδυτική πλευρά και διαμορφώνεται με λίθινο τόξο.
- Μικρά ανοίγματα και παράθυρα βρίσκονται στη νοτιοανατολική πλευρά.
- Η κατασκευή έγινε με ντόπια υλικά με τοπική πέτρα και παραδοσιακά κονιάματα.

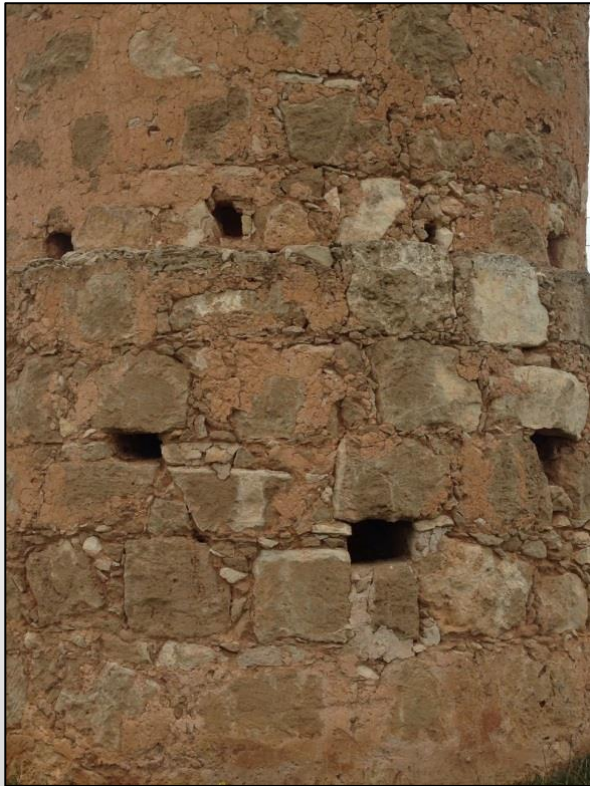
**Τοίχοι:** κατασκευασμένοι από τοπική ασβεστολιθική πέτρα και παραδοσιακό κονίαμα.

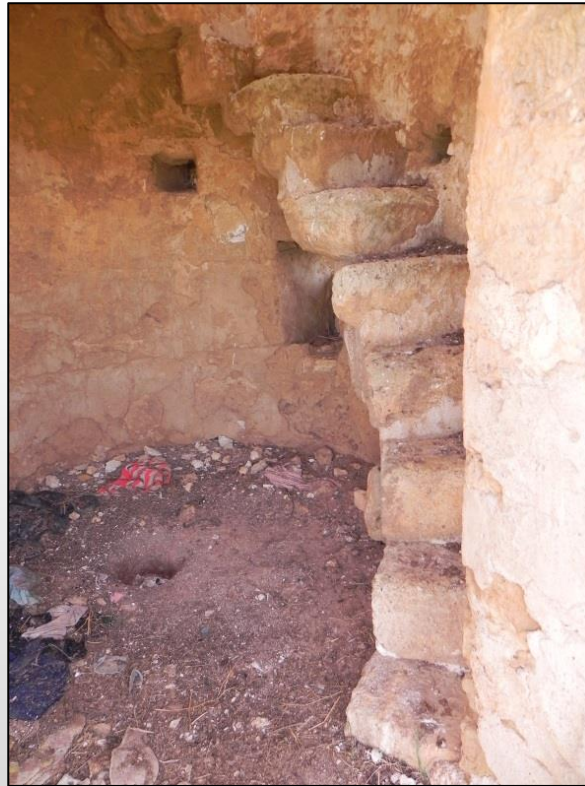
**Δάπεδο:** δεν σώζονται στοιχεία του αρχικού δαπέδου.

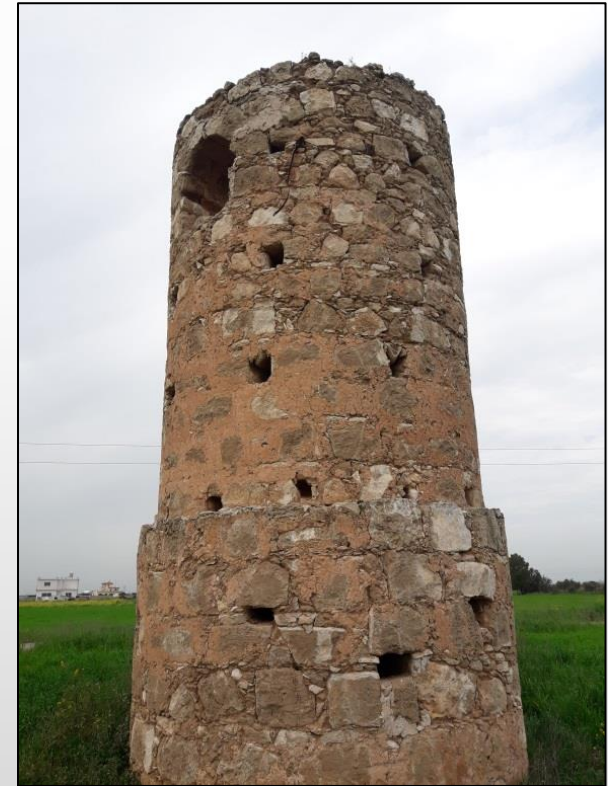
**Οροφή:** κωνική αχυροσκεπής κατασκευή με ξύλινο σκελετό?

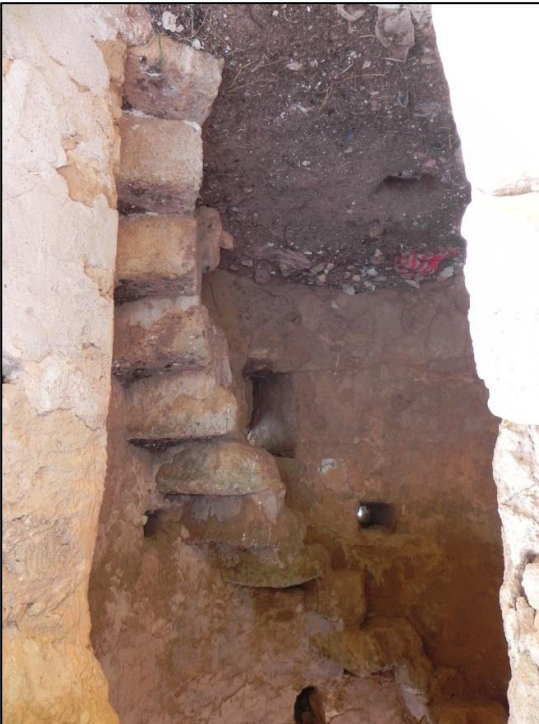
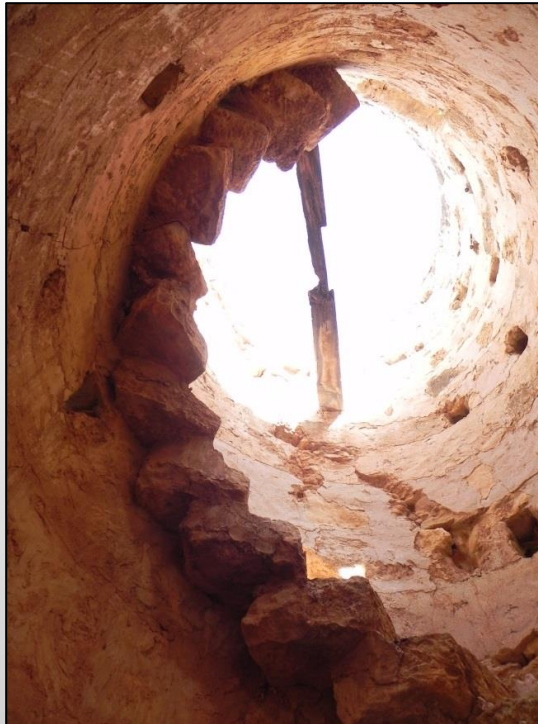
## 11. Εσωτερική Διάταξη και Λειτουργία του Ανεμόμυλου Λιμνιών

- Ενσωματωμένες πέτρινες σκάλες μέσα στους τοίχους οδηγούσαν στους ανώτερους ορόφους.
- Πιθανότατα διέθετε τρία επίπεδα: ισόγειο, ενδιάμεσο όροφο και ανώτερο όροφο.
- Στον ανώτερο όροφο βρισκόταν ο μηχανισμός άλεσης.
- Η αρχική οροφή δεν διασώζεται, αλλά πιθανότατα ήταν κωνική και καλυμμένη με άχυρο.
- Δεν έχουν διασωθεί στοιχεία του αρχικού μηχανισμού λειτουργίας, ο οποίος πιθανόν αφαιρέθηκε όταν χρησιμοποιήθηκαν νεότερες μηχανές άλεσης.

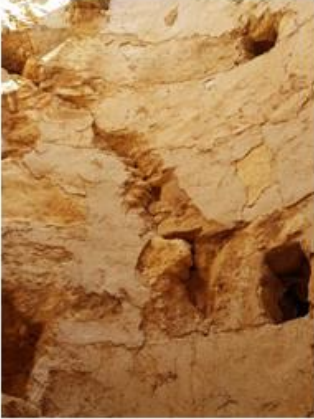
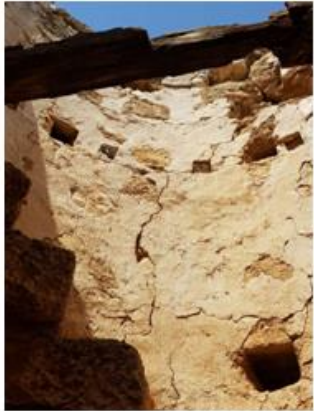
| Stone masonry walls/Jointing mortar | | | |
|---|---|---|---|
| SC | Structural cracks | | <ul style="list-style-type: none"> <li>Severe cracks are located at the interior of the windmill are probably due to: <ul style="list-style-type: none"> <li>The partial collapsed masonry wall on the outside surface.</li> <li>The various openings, cracks are governed to the weakest points.</li> </ul> </li> </ul> |

- ✓ Strengthening of the masonry walls through the homogeneity of the masonry's consistency by using grout injections.
- ✓ Re-construct and restore the partially collapsed and/or missing sections of stone masonry walls.
- ✓ Repair all major cracks using the stitching technique (placement of horizontal stainless steel rods inside the joints, perpendicular to the cracks) and deep grouting injection if necessary.
- ✓ Provide a stiff connection at the roof level by installing a wooden boundary ring beam above the stone masonry walls in order to ensure a diaphragmatic rigidity when subjected in lateral forcing.
- ✓ Replacement of heavily decayed/damaged stones.
- ✓ Protect the structure from humidity that causes material deterioration.

Healing of cracks using the stitching method accompanied with stone stitching and grouting injections

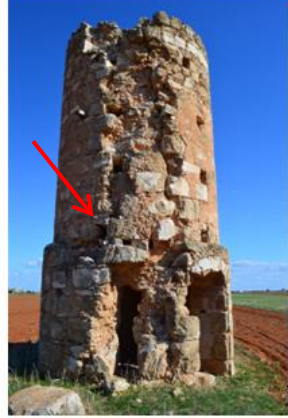
| PCW | Partial Collapsed wall | | <ul style="list-style-type: none"> <li>Local loss of the outer stone layer with the rest of the three-layered masonry. Probably caused by: <ul style="list-style-type: none"> <li>Absence of a diaphragmatic (box) behavior.</li> <li>Horizontal movements generated by earthquakes. The structure is positioned on soft soils with a ground acceleration of 0,25g (Seismic zone III) which makes it vulnerable to high intensity earthquakes.</li> </ul> </li> </ul> |

Re-construct and restore the partially collapsed and/or missing sections of stone masonry walls.

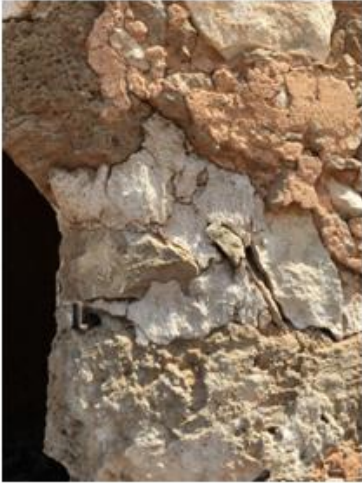
| DMR | Decayed of jointing mortar/rendering. | | <ul style="list-style-type: none"> <li>Deterioration of the existing mortar and plaster rendering.</li> <li>Lack of maintenance and abandonment of the place (wear and tear) over the years. Structure left to the elements (wear and tear).</li> <li>Partial detachment of the render used in the windmill.</li> <li>Based on the results given from the technical laboratory, the rendering material used is an earth lime based mixture that has poor strength characteristics in comparison with the lime based jointing mortar.</li> <li>Loss of small stone filling at the masonry joints.</li> </ul> |

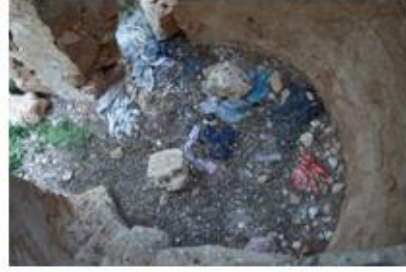
| D | Debris | | <ul style="list-style-type: none"> <li>Lack of maintenance and abandonment of the place.</li> <li>The interior floor of the windmill is covered with plastic debris.</li> </ul> |

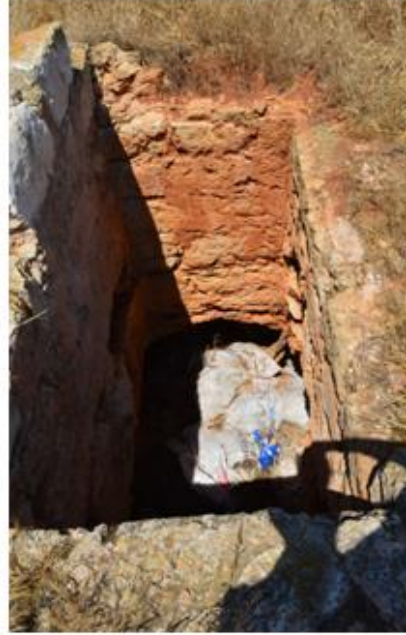
| W | Well | | <ul style="list-style-type: none"> <li>Lack of maintenance and abandonment of the place.</li> <li>The well is full of debris and dead decomposed animals.</li> </ul> |

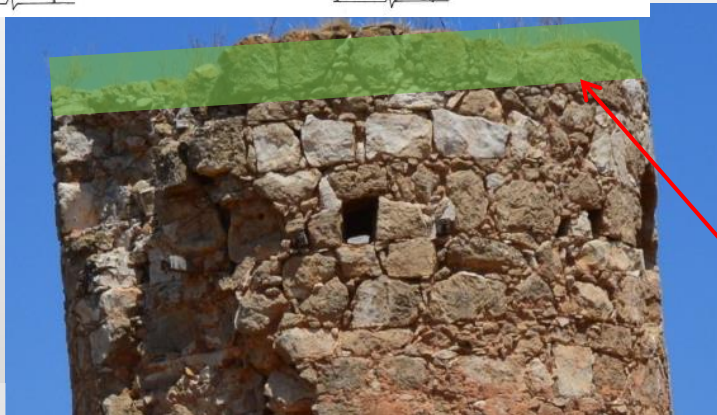
Provide a stiff connection at the roof level by installing a wooden boundary ring beam above the stone masonry walls in order to ensure a diaphragmatic rigidity when subjected in lateral forcing.
