PANAGIA MELANDRINA CHURCH

Structural Assessment And
Design Of Emergency Repairs
And Supporting Measures

***BIENNIAL OF ARCHITECTURAL AND
URBAN RESTORATION,***

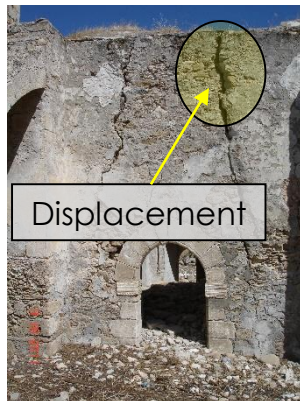
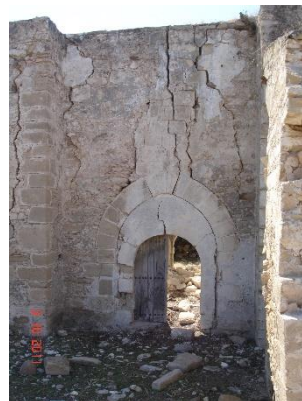
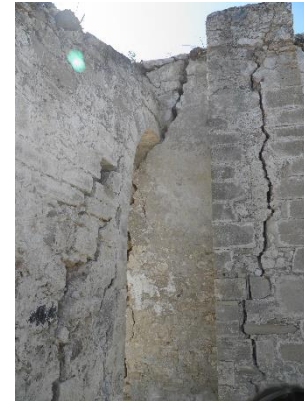
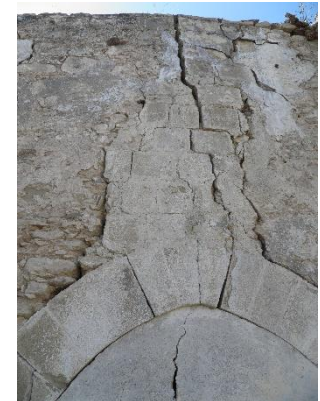
- Objective involved the assessment of both the **body of the Church** itself and the added **Counterforts**.
- Very bad structural & general condition - Extensive damages and deformations on the load bearing systems due to:
 - earthquake activity & ground movements
 - lack of regular maintenance / restoration / renovation.
- Very poor or no joining & adhesion of stones leads each structural component to act individually according to its own mechanical / dynamic characteristics – Walls with no monolithic behaviour / Roof with no diaphragmatic action.
- Extensive severe cracks on the load bearing masonry of the Church – Mostly out-of-plane cracking patterns.

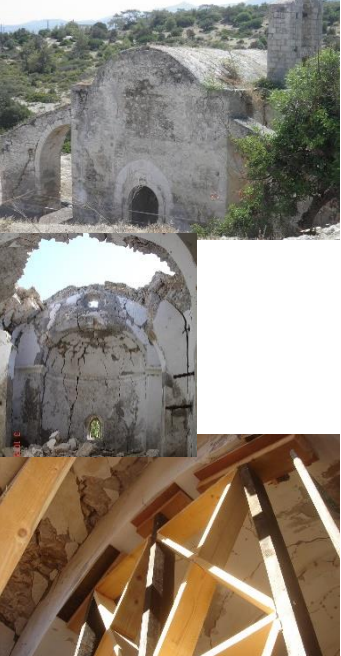
- Extensive severe cracks on the load bearing masonry of the Church – Large dislocations & torsional displacements on E side.

- **Grouting of all large cracking** - Grouting injections with lime-based mortar inside the masonry wall in all large cracks in order to re-establish the wall's homogeneity.

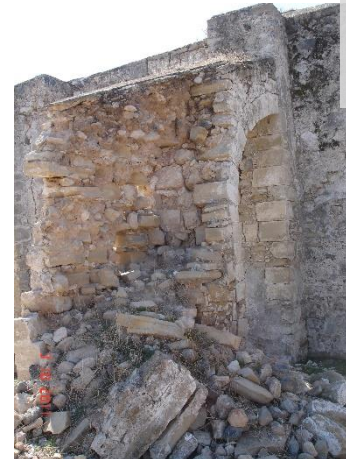
- Extensive severe cracks on all counterforts and partial collapse of one of them.

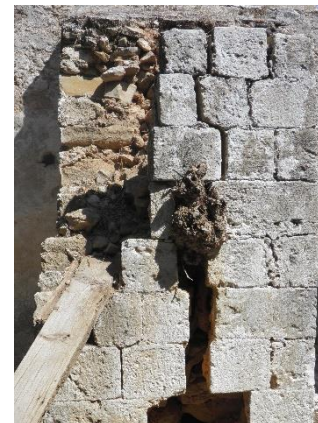
- Uncontrolled plantation / vegetation inside the body of the walls, roof and counterforts.

- **Removing plantation / vegetation with pesticide** - Growing plantation causes further damage in the body of the walls. Plantation should be removed before and after the completion of emergency measures

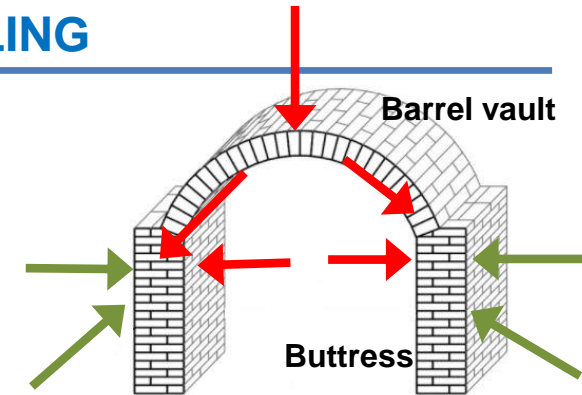
Figure 1 - Barrel Vault ¹

- Barrel Vault behavior:
 - Figure 1: Integrity is ensured when internal loads [red arrows] are in equilibrium with external forces [green arrows].
 - Figure 2 & 3: Integrity is breached when equilibrium is disturbed either by failure of the supports or instability of the lateral elevation. In both cases, hinges and hence mechanisms are developing that lead the system out of balance.
- In our case, absence of monolithic action, no diaphragm & weak buttresses due to poor binding mortar led to system instability

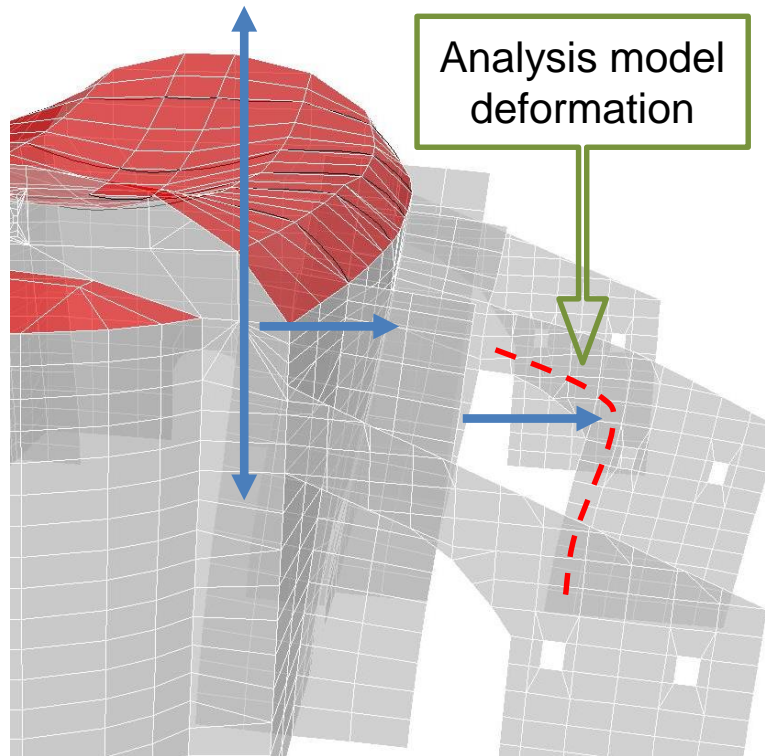
- Counterforts behavior:
 - Simply attached to the body of the Church – No participation in gravity loads.
 - All diagonal cracks are due to horizontal “pushing” coming from the main structure’s vertical deformation.

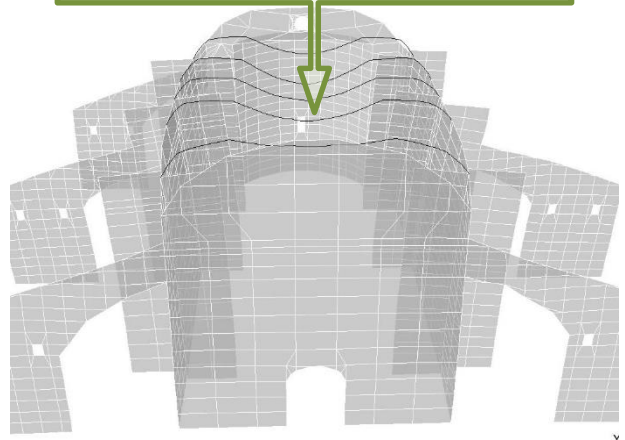
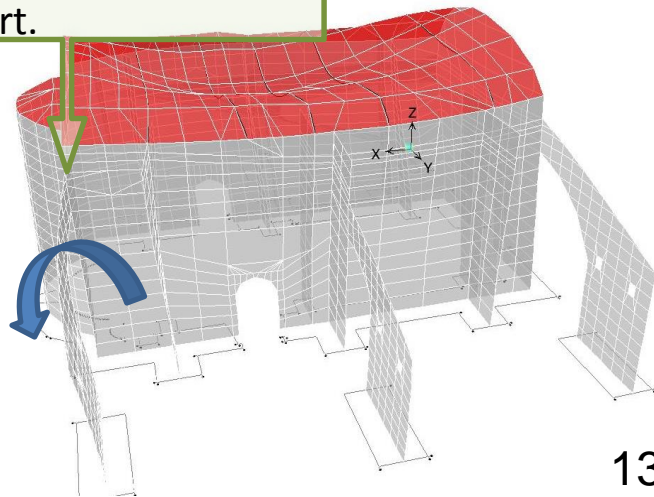
Poor diaphragmatic behavior

Some counterforts support / retain the buttresses while others the body of the church. That causes bad stiffness distribution making strong parts (corners) stronger and weak ones (middle body) even weaker.

Over-stretching of the arched roofing system – barrel vault action breached

Vertical, horizontal & torsional dislocation of N-E corner leading to large cracking and failure of the counterfort.

Overstressing - Failure / collapse.
