# Conservation of Mosque in Kalo Chorio/Vuda, Larnaca District UNDP CYP RFQ 210 2020

## Set of Condition Assessment drawings

Following the architectural survey, a detailed conditional assessment was carried out to document and assess the pathology of the structure. Both the minaret as well as the mosque itself were investigated in great detail for structural damage.

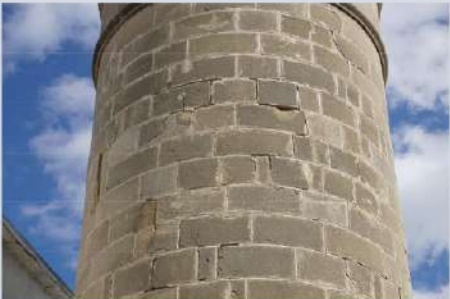
<p>PH. 2</p>

<p>PH. 5</p>	<ul style="list-style-type: none"> <li>• GENERAL   Laboratory testing must be carried out to specify material characteristics.</li> <li>• PH. 1 &amp; 5 – Damaged concrete elements &amp; Rusted steel elements   Deteriorated concrete must be fully removed until health surface is reached. Corroded reinforcement, if any, must be thoroughly cleaned and / or replaced where extensive damage or loss of section is observed. Protection paint should then be applied and final coating with high strength repairing mortar. Repairing of brackets supporting the platform. Existing rail to be thoroughly cleaned from rust, repaired where necessary and application of anti-corrosion epoxy paint system for protection.</li> <li>• PH. 2 – Rusted Lintel   Existing lintel steel elements to be thoroughly cleaned from rust. If remaining section is structurally sufficient, application of anti-corrosion epoxy paint system for protection should be carried out. If loss of section is observed, replacement should be done carefully and following specific and approved methodology.</li> <li>• PH. 3 &amp; 4 – Cracks on masonry wall / Deformed staircase stone axis   Structural tying of the minaret in specific levels to form a monolithical shaft section. All major cracks to be sealed with lime-based mortar injections.</li> </ul>

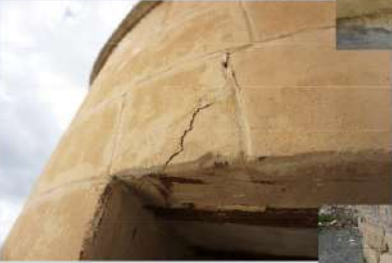
<p>PH. 6</p>

<p>PH. 11</p>	<ul style="list-style-type: none"> <li>PH. 6, 7 &amp; 9 – Deteriorated stone elements, missing stones and older cement interventions in the base   Removal of all cement repairs, replacement of stone elements where loss of section is significant, deep pointing &amp; jointing of the entire base, structural tying / capping of the base either by tie rods or stitching techniques.</li> <li>PH. 8 – Cracked lintel on both ends   Existing lintel steel elements to be thoroughly cleaned from rust and protected with anti-corrosion epoxy paint system. Further strengthening of the opening by installing glass fiber tubes or s/s bars anchored in a crossing form with the use of epoxy resin.</li> </ul>

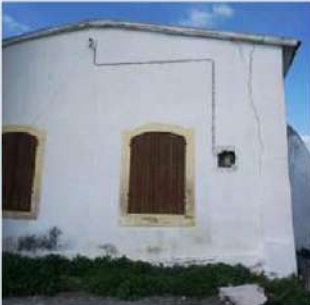
<p>PH. 18</p>

<ul style="list-style-type: none"> <li>PH. 18 – SE corner wall deformation   Wall deformation shows shifting of the corner towards east. Structural tying of the wall with the use of tie rods.</li> </ul>

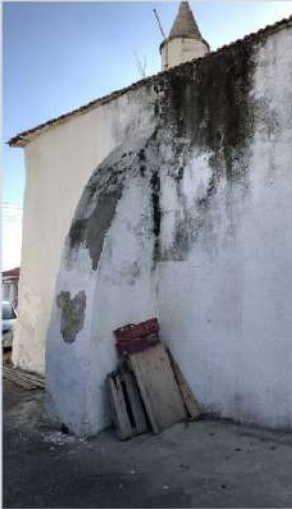
<p>PH. 19</p>

<ul style="list-style-type: none"> <li>PH. 19 – Strengthening of the buttress section near the base or full reconstruction, water drainage system (gutters / downpipes) on the roof to avoid water flow on the wall.</li> <li>PH. 20 &amp; 21 – Cracked floor slabs   Floor to be repaired. Floor slabs to be removed, slab on grade and tie beams to be constructed, floor slabs to be put back in place, replacement of those who are cracked and damaged. Joint sealing.</li> <li>PH. 22 – Deformed roof joists   All roof joists must be removed and replaced. Wooden tie beams must be introduced at the top of both supporting walls.</li> <li>PH. 23 – Heavily moistened east wall   Damaged wall plaster to be replaced, proper water drainage system (gutters / downpipes) on the roof to avoid water flow on the wall and water penetrating inside.</li> </ul>

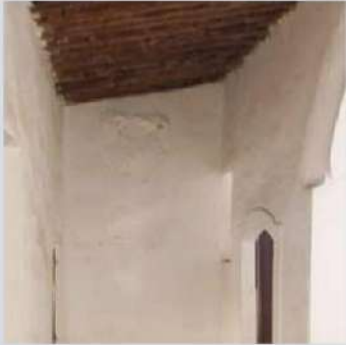
<p>PH. 24</p>

<p>PH. 29</p>		<ul style="list-style-type: none"> <li>• PH. 24 – Weak swollen plaster   Plasters to be removed, inspection of wall and cracks treated accordingly, deep pointing and jointing to be carried out, lime based plaster to be applied where necessary.</li> <li>• PH. 25 – Detached plaster and damaged masonry   Damaged adobe wall to be replaced or strengthened with the use of wooden wedges and planks, plaster replacement.</li> <li>• PH. 26 – Wall structure disorganized and absence of homogeneity   Plaster to be fully removed, wall to be cleaned thoroughly and deep pointing and jointing to be carried out in order to form a bonded wall section. Stitching to be performed at all corners and T-junctions.</li> <li>• PH. 27 – Existing wooden lintel   Wooden beams in a fairly good condition. Wooden sections to be treated and protected properly with suitable protective paint.</li> <li>• PH. 28 &amp; 29 – Stone arch cracked edge   Strengthening and restoring measures to be applied. Replacement of stone elements where loss of section or structural deficiency is significant, structural tying of the stone arched frame either by tie rods or stitching techniques. Finally, deep pointing and jointing.</li> </ul>

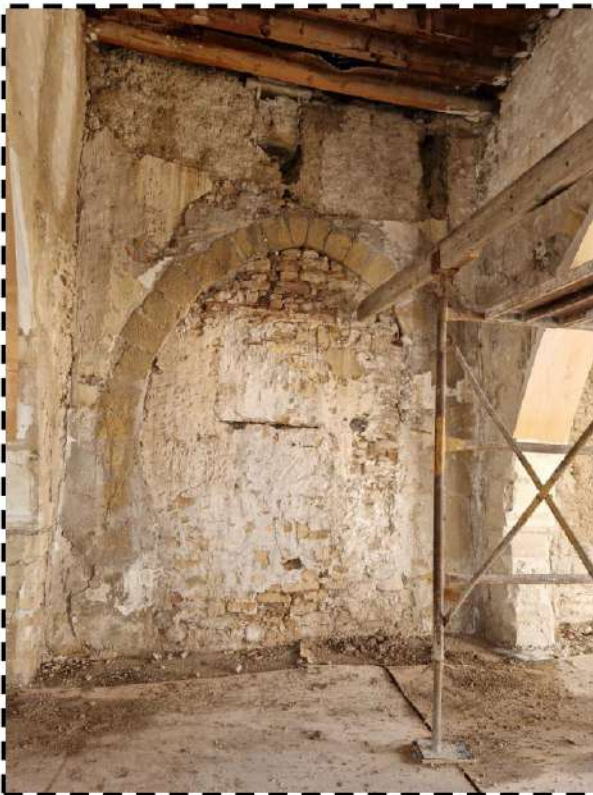
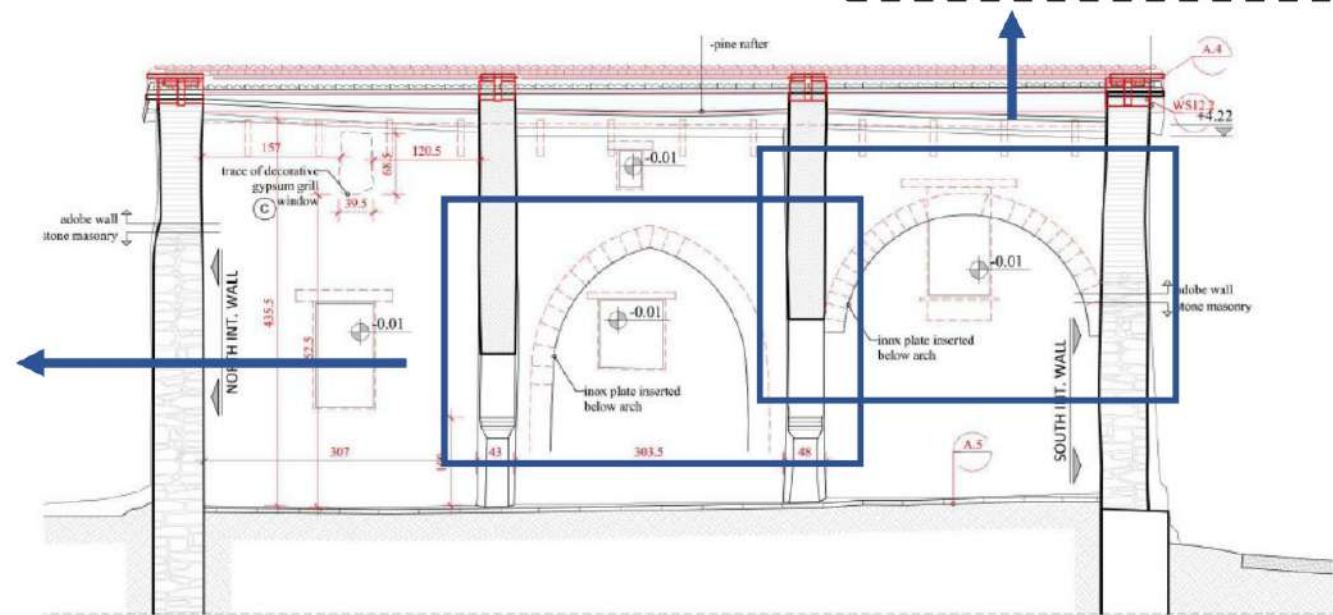
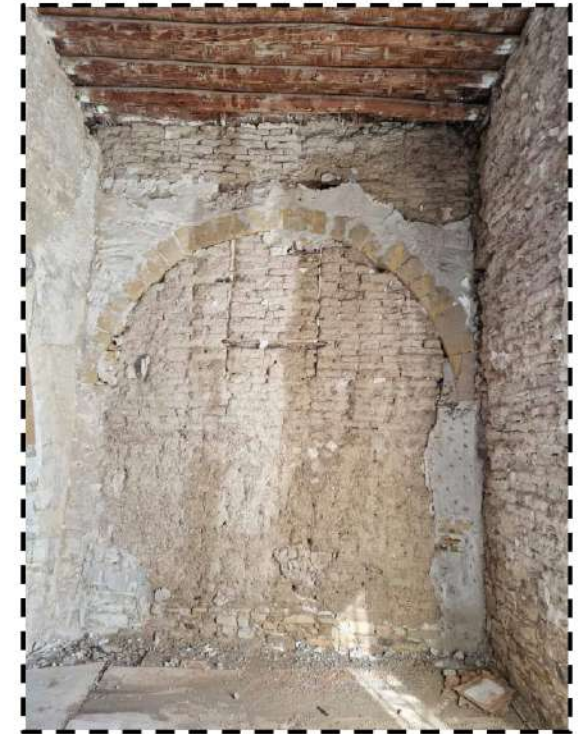
Interior wall East  
Scale: 1:50

- ➔ Removal of internal plasters had led to the discovery of **past hidden arches** inside the masonry wall's surface as well as **past window openings** that were all later filled!
- ➔ The new findings were recorded and documented by the Architects and Conservators of the design team.
- ➔ The final decision made between the AB, UNDP and the Designer's team was to **indicate the past openings and arches with a small recess** from the plaster, in order to keep the historical memory alive.

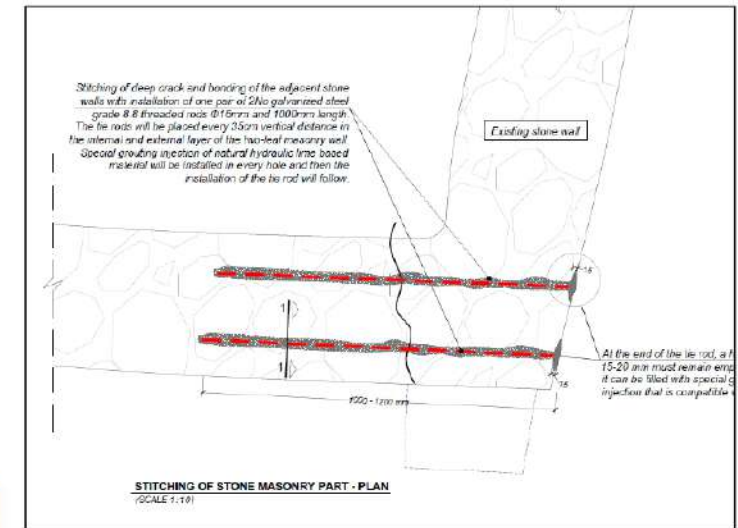
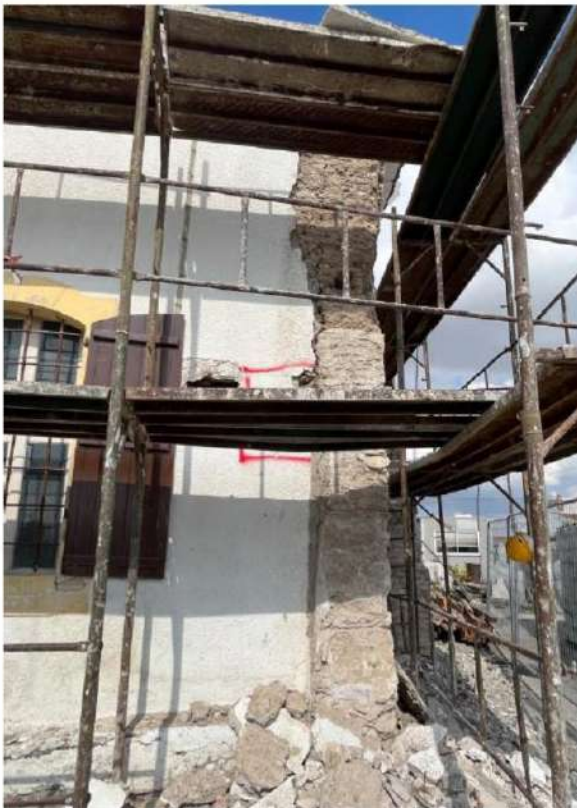
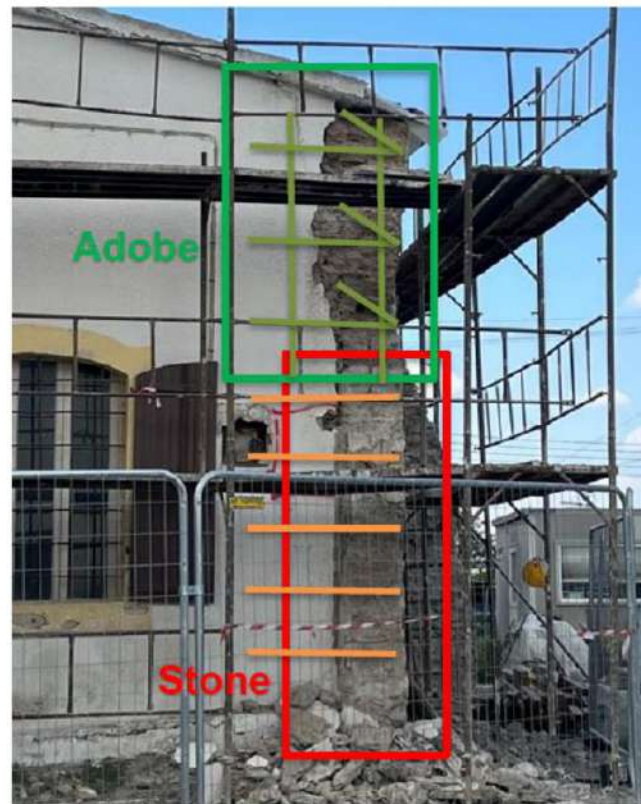
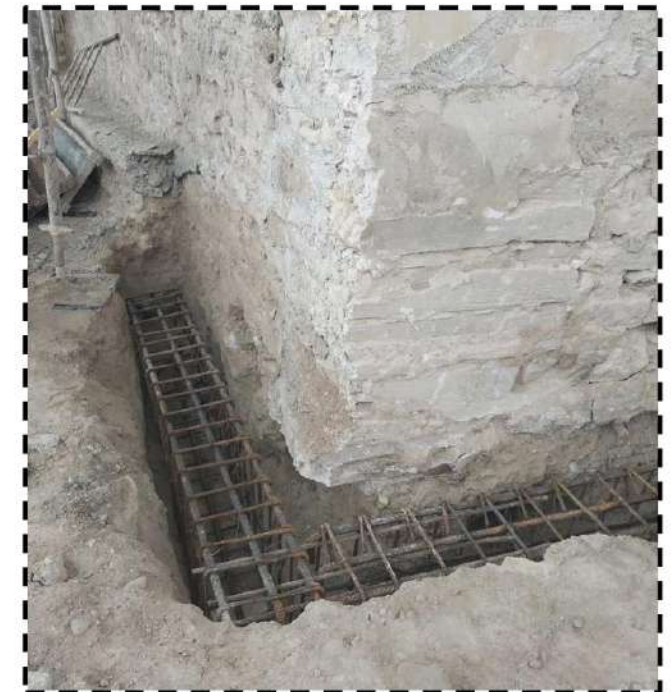
Photo – 8: Existing S-E corner wall typology – bottom half part made of stone masonry, upper half part made of adobe masonry

Questions were raised concerning the South-East corner stitching detail which must be revised after the discovery of the new hidden arch. After the removal of the interior plaster and some of the arches, the pier of the arch was found to made of stone units, contrary to the adobe wall that was given in the drawings.

- ➔ South-East corner stitching detail was revised after the discovery of stone wall at the bottom and adobe wall on the top half.
- ➔ The lower stone part was reinforced with galvanized steel threaded tie rods installed every 35mm vertically apart with special NHL grouting material.
- ➔ The upper adobe corner was tied with timber corner elements as per the initial design approach.

- The Designer advised that the crack stitching detail as per W6.2 is not appropriate for the bottom part of the wall that is made of stone masonry, but only for the upper half which is consistent of adobe bricks.
- It was stated that a new detail will be sent the following day (Sketch – 3).
- The Designers clarified that the upper half part will be repaired as per W6.7.1 and W6.7.2 according to the detail of the installation of timber corner elements internally for bonding of the adjacent walls and the stitching of the deep crack externally with timber vertical and horizontal elements.
- Additionally, for the lower stone masonry wall, galvanized steel threaded de rods of 8-16 mm will be installed every 35 cm vertically with special grouting injection of M40 material, as per detail attached (Sketch – 2).

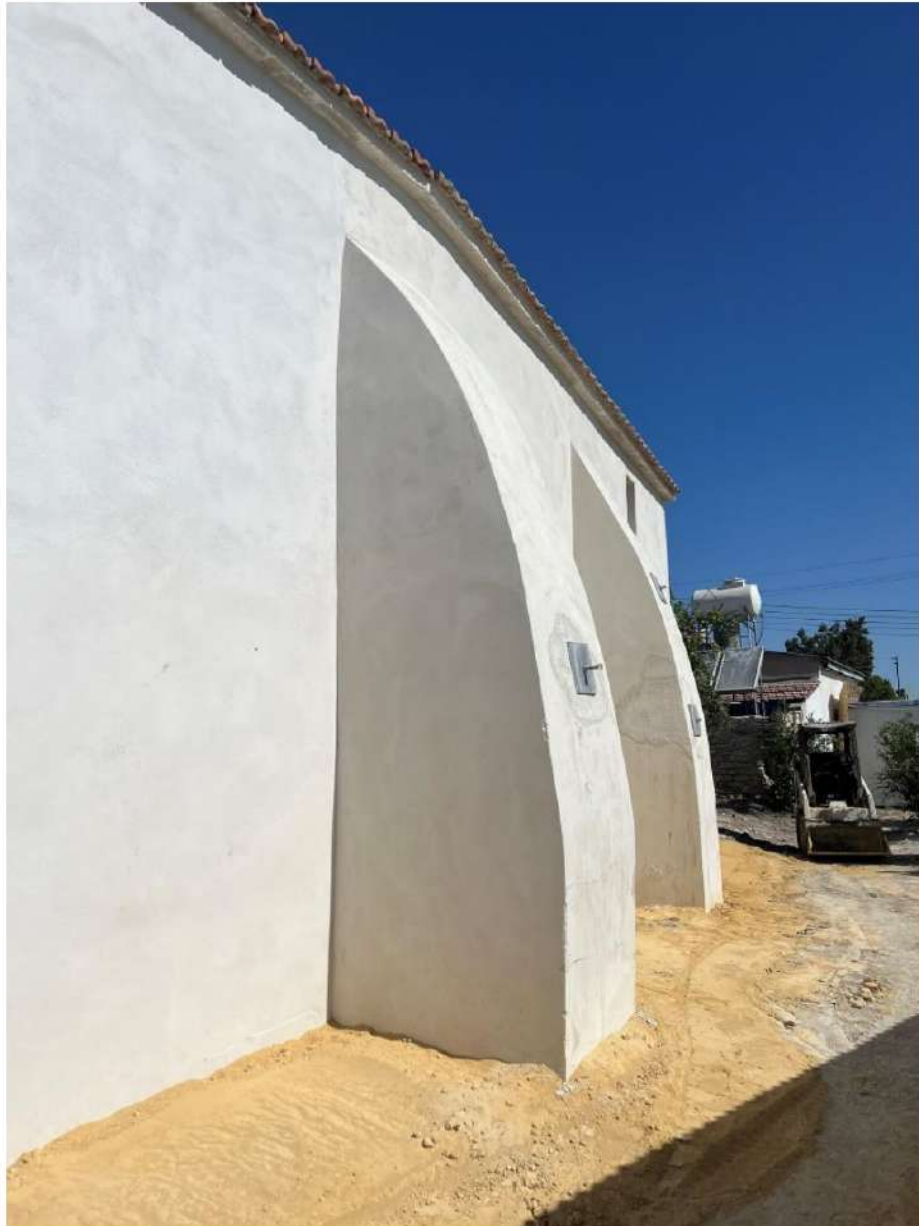
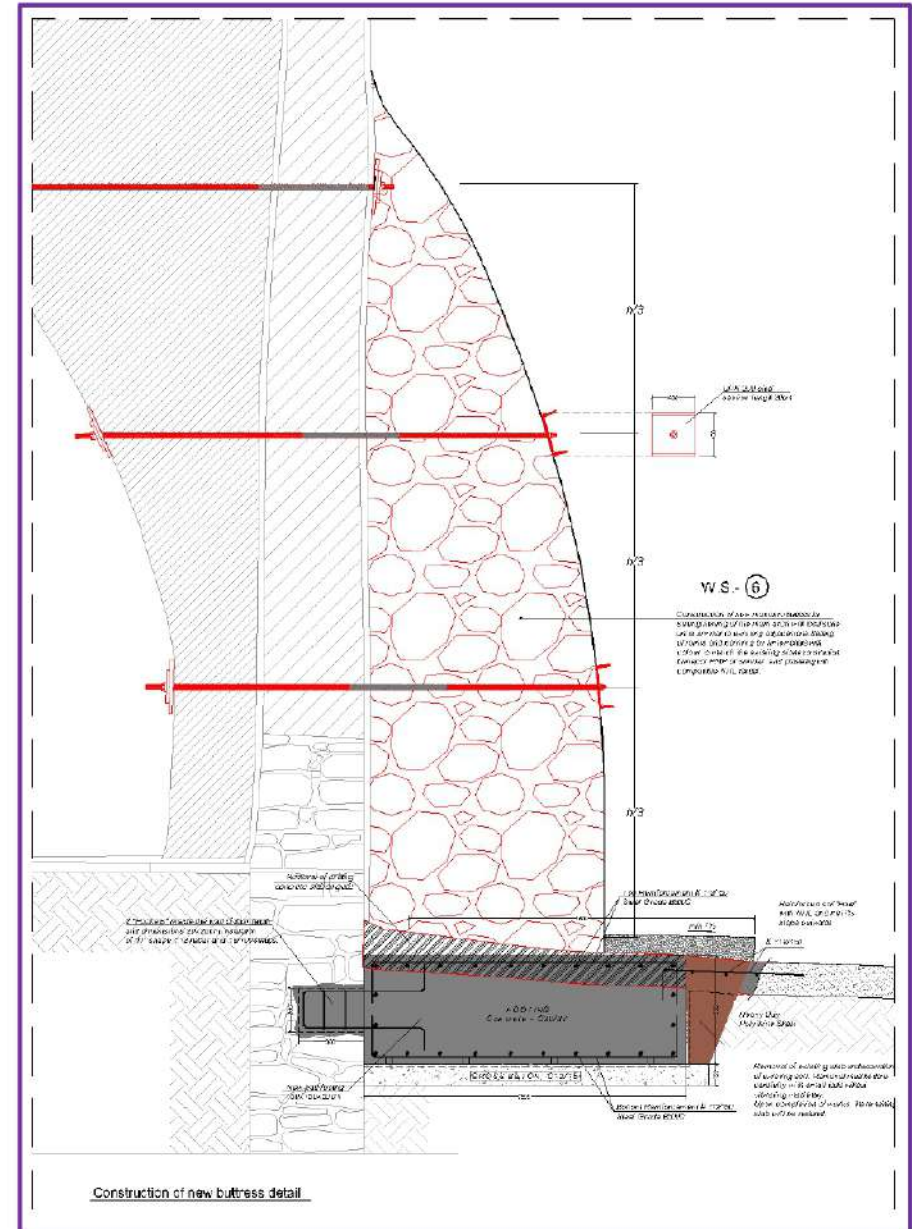
➔ Construction of **new buttress** to counteract the lateral forces of the main arch along with the installation of steel tie rods

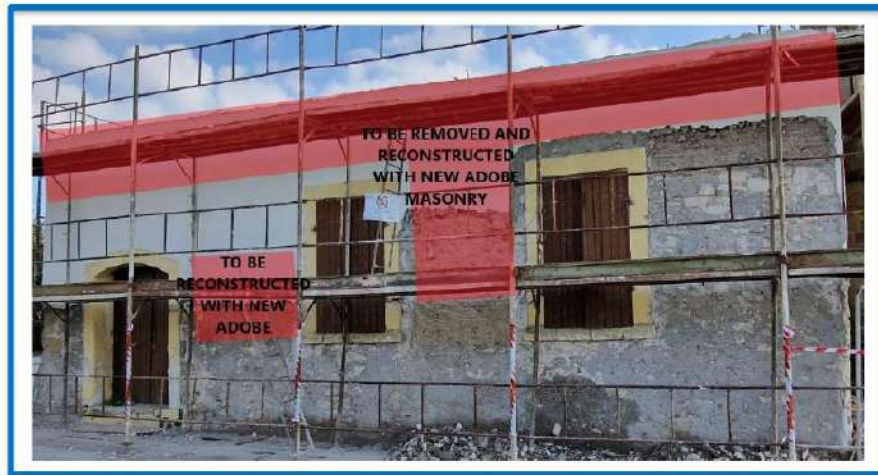
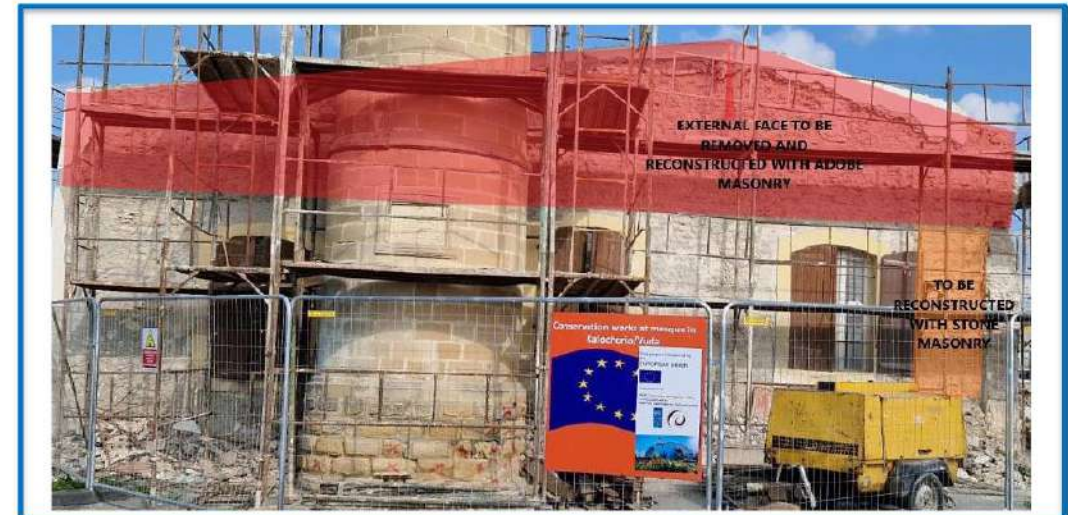
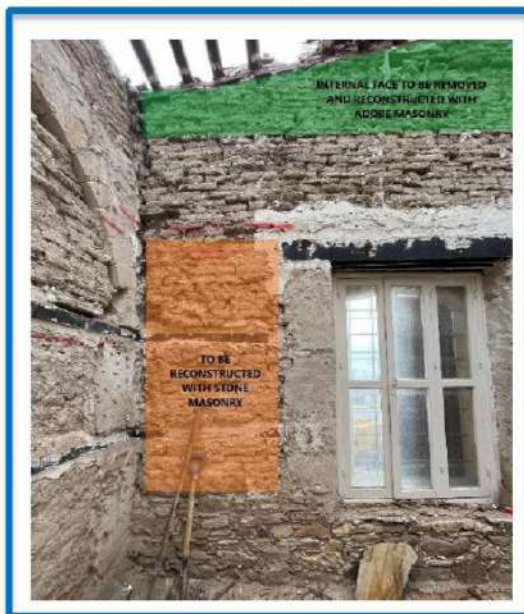
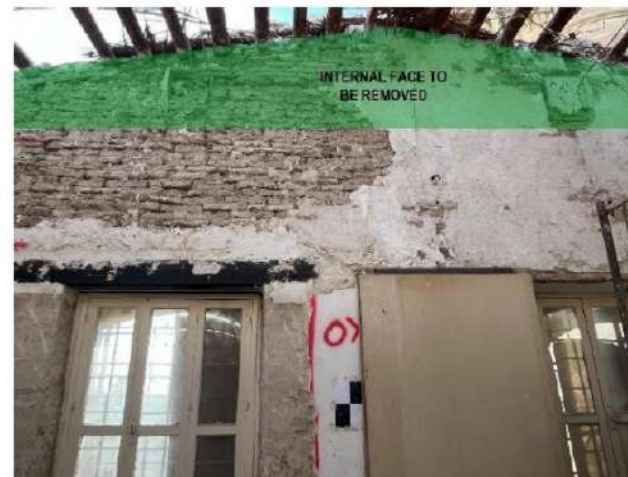
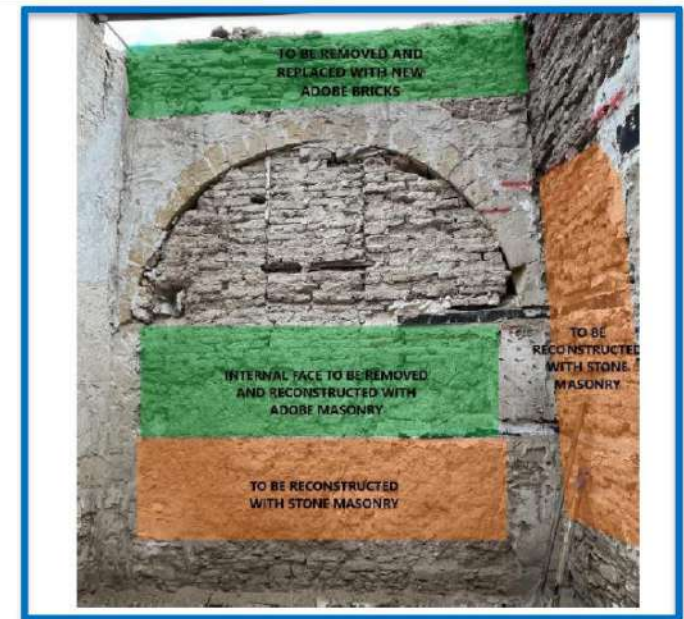
- ➔ Advice on which parts of adobe masonry walls should be removed and reconstructed due to their heavy deteriorated state.
- ➔ The majority of the adobe bricks were found heavily damaged and deteriorated, possibly by the trapped moisture inside the surface of the wall due to the incompatible cementitious “splits” plaster and/or leaks from the roof.

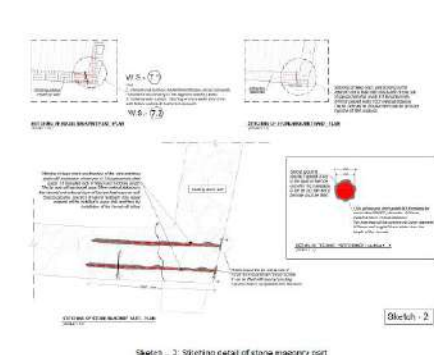
SKETCH – 2

Sketch – 2: Stitching detail of stone masonry part

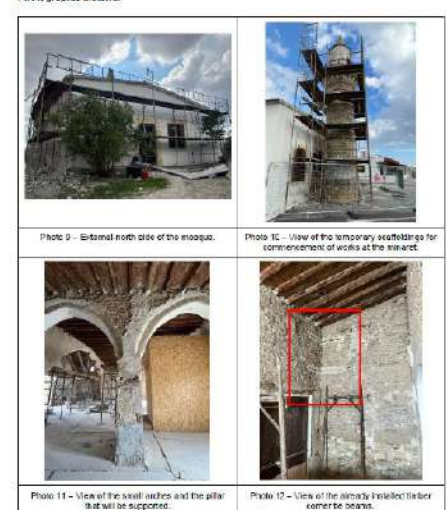
Photo 9 – External north side of the mosque.

Photo 10 – View of the temporary scaffolding for commencement of works at the minaret.
